## SOME OF RECOMMENDATIONS AND LEARNED LESSONS FROM BUILDINGS' PERFORMANCE DURING THE RECENT TURKEY-SYRIA EARTHQUAKE

RANIA AL-AHMAR\* MAYADA AL AHMAD AL KOUSA\*\* and GEORGE WARDEH\*\*\*

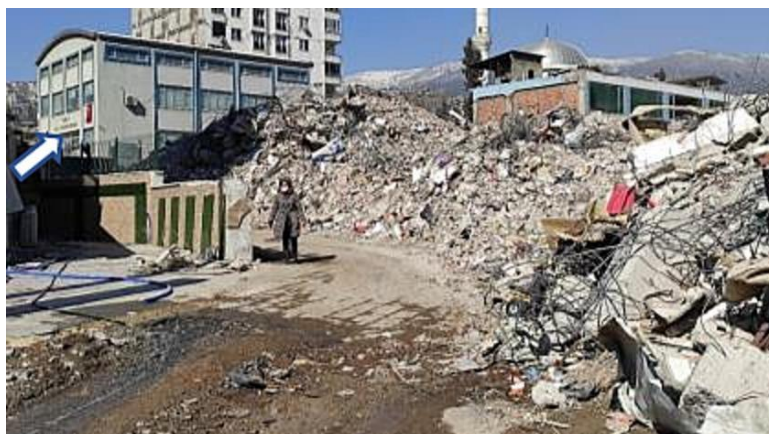
Buildings in the areas affected by the Turkey-Syria earthquake responded differently, ranging from complete or partial collapse, to severe, moderate, or minor damage, or just cracks, while other buildings remained intact without any damage. Structures can be classified according to the date of their construction and their dependence on seismic codes in their design into old structures and newer structures (Lekkas et al., 2023). Figure 1 shows an example of buildings that were not damaged as a result of the good quality of both design and construction, which is Kahramanmaraş Chamber of Civil Engineers building (indicated by an arrow), while damaged buildings with completely collapse were appeared beside it.

**Fig.( 1):-** The difference in the seismic response and damage of adjacent buildings, Kahramanmaraş (OZTURK et al., 2023).

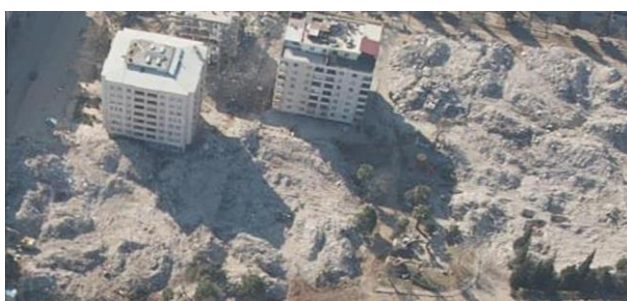
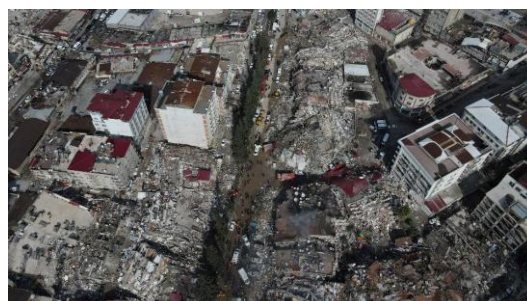
river-extracted, shiny and smooth aggregates and gravels, and inadequate compacting during concrete placement. As well as the reinforcing steel bars, which did not have any trace of cement paste left on their surface, which can be explained by the poor quality of the concrete with the insufficient amount of cement. The effect of reducing the compressive strength of concrete is more significant in columns compared to slabs and beams, where the axial forces dominate the behavior of the columns. Because of the poor quality of the concrete, many of buildings are completely collapsed and become like piles of gravel and sand (Lekkas et al., 2023; OZTURK et al., 2023), as shown in Fig. 2.

**Fig.( 2):-** Wreckages of destroyed buildings resemble heaps of sand and gravel (Lekkas et al., 2023; OZTURK et al., 2023).

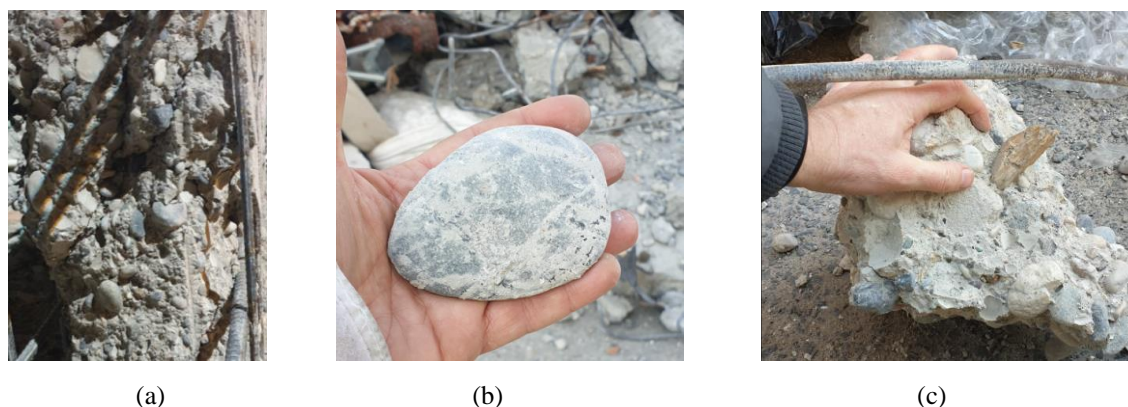
dates of issuance of modern seismic codes (Mertol et al., 2023). Figure 3 shows that most of the concrete of the ruins of collapsed and

severely damaged buildings contains round aggregates, large aggregates with diameters ranging between 50 and 100 mm, in addition to the presence of materials such as wooden pieces

within the concrete. All of these observations reduce both the resistance of the concrete and the bonding between concrete and reinforcements (Mertol et al., 2023).

**Fig.( 3):-** Poor quality of concrete: (a) aggregates having round shapes; (b) oversized aggregates; (c) Woodcuts in concrete. (Mertol et al., 2023)

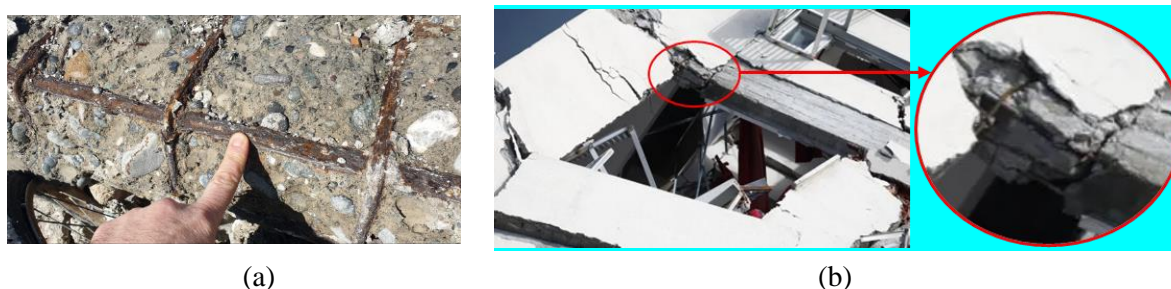
structural performance under static and dynamic loads (Yu et al., 2017). Extensive corrosion was seen in the longitudinal and transverse reinforcements of some of the severely damaged or collapsed buildings (Mertol et al., 2023). The cause of corrosion may also be because the owner of the building does not pay enough attention to its structure. For instance, not taking proper corrosion precautions in a building subject to corrosion (OZTURK et al., 2023). Figure 4 shows corrosion in stirrups, longitudinal rebars, and beam-column joints which reduce the connection ductility during earthquake sequence.

**Fig.( 4):-** Corrosion in: (a) longitudinal and transverse reinforcements (Mertol et al., 2023); and (b) beam-column connection (Alhawamdeh et al., 2023).

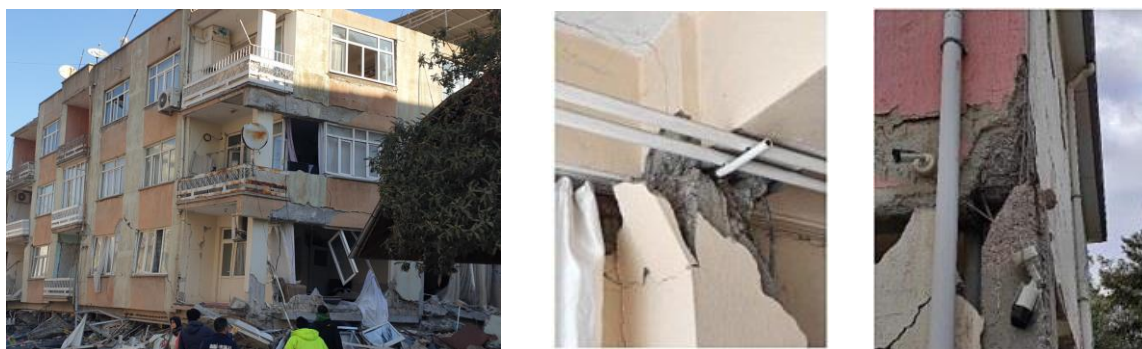
joints between the columns and the horizontal elements (beams or slabs) were also insufficient, which canceled their supposed resistance, resulting in structural deficiencies (Lekkas et al., 2023). The reason for column collapses in many buildings may be due to a lack of achievement of the concept of a weak beam and strong column using the capacity design concept. See Figures 5 and 6 for more details.

Fig.( 5):- collapse and damage due to strong beam and weak column (Mertol et al., 2023; OZTURK et al., 2023).

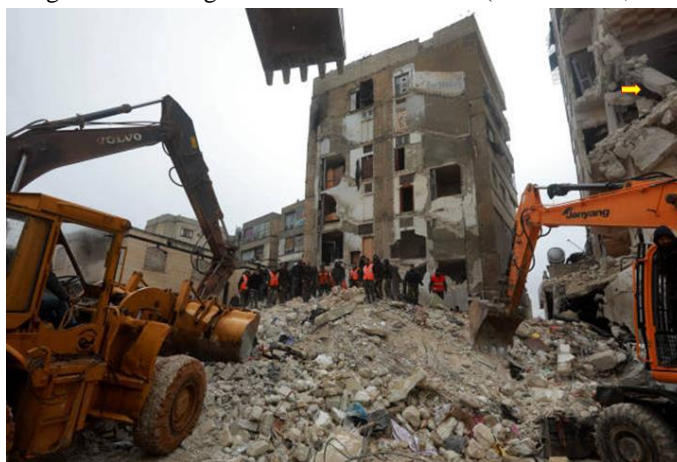
Fig.( 6):- Extensively damaged RC columns (marked by arrows) in a building adjacent to ruins of a collapsed building in Hama (Alhawamdeh et al., 2023).

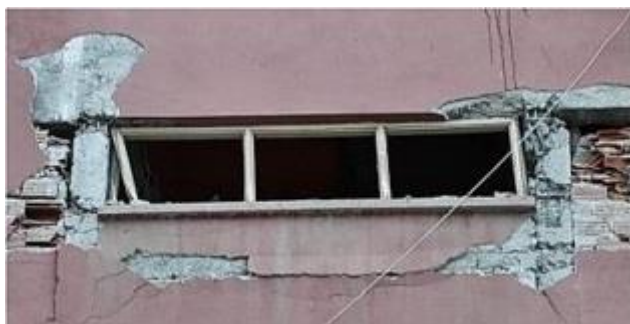
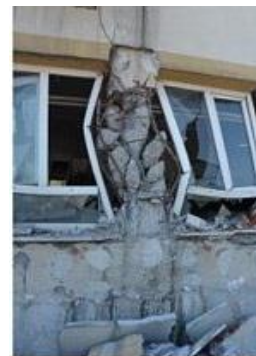
between columns in infill walls are some of the reasons for the appearance of the short column problem. Shear damage is unavoidable because this column is subjected to a higher shear force than was anticipated during the design phase (Fig. 7). The design of these short columns must be based on the approach of capacity design and take into account the requirements of the transverse reinforcement (OZTURK et al., 2023).

**Fig.( 7):-** Damage due to the short column formation in some buildings (OZTURK et al., 2023).

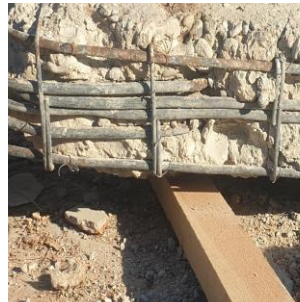
As shown in Figure 8 inadequate lap splice and anchor lengths, transverse reinforcement, and beam-column joints with insufficient shear

capability cause building collapses and considerable damage (Alhawamdeh et al., 2023; Mertol et al., 2023; OZTURK et al., 2023).

**Fig.( 8):-** Examples of inadequate: (a) anchorage length in beam (OZTURK et al., 2023); (b); transverse reinforcement (OZTURK et al., 2023); (c) stirrup ends' bend (Mertol et al., 2023); and (d) beam-column joint (OZTURK et al., 2023).

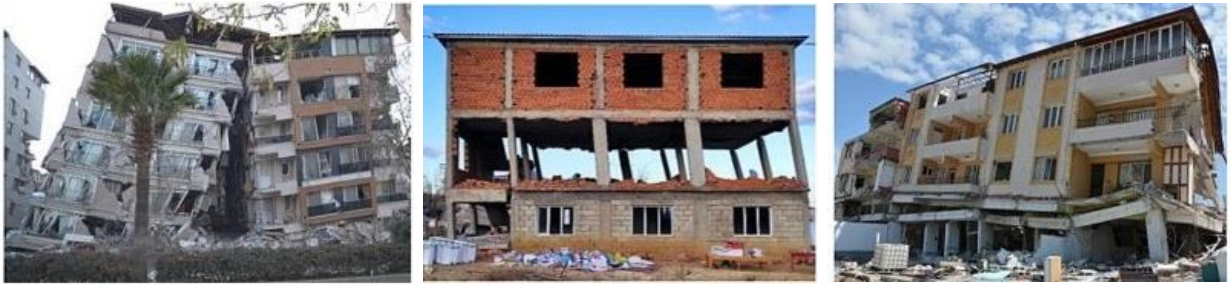
One of the most important causes of collapse and damage to reinforced concrete structures during earthquakes in all countries of the world is the soft story and the weak story problems (see Figure 9). The ground stories are generally used for commercial purposes or parking garages, and the heights of the ground stories are higher than the other stories. Lateral displacements are increased in soft stories due to the removed backfill walls and depending on the decrease in the lateral stiffness of the columns due to the height of the floors. In addition, sudden changes in the strength and stiffness of

stories adversely affect the performance of buildings during an earthquake (OZTURK et al., 2023). Many buildings collapsed with a soft

**Fig.( 9):-** Collapses resulting from soft or weak stories in RC buildings (OZTURK et al., 2023).

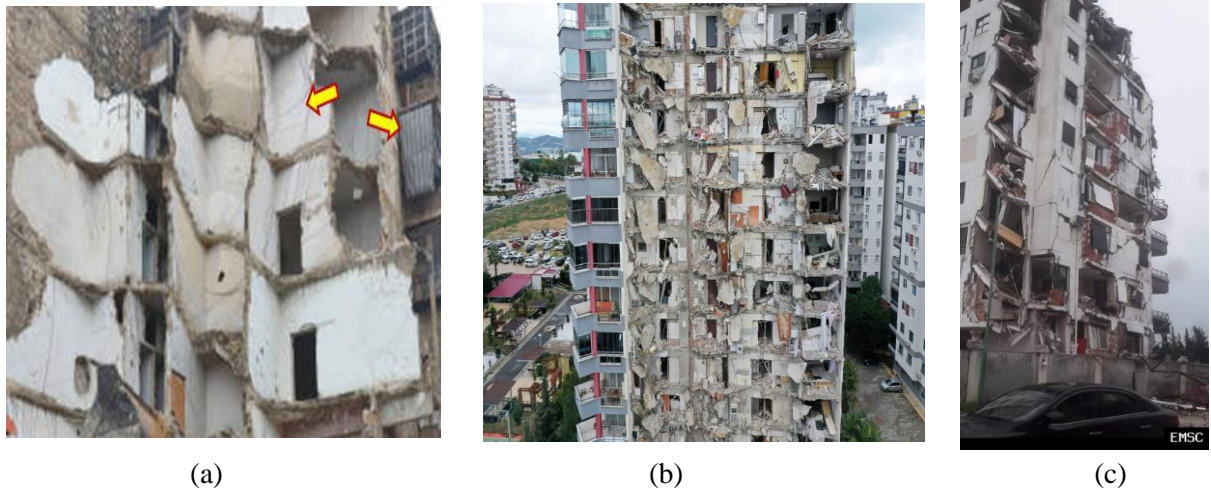
story mechanism or out-of-plane (OOP) construction failure, as displayed in Figure 10 (Alhawamdeh et al., 2023; OZTURK et al., 2023) and Figure 11 (Alhawamdeh et al., 2023). Where the collapse of infilled or masonry walls during the first earthquake can lead to the formation of weak and soft stories, which can lead to building collapse during the second earthquake or the aftershocks between them.

**Fig.( 10):-** Collapse of masonry or infilled walls of buildings in: (a) Aleppo (Alhawamdeh et al., 2023); (b) Adana (Lekkas et al., 2023); and (c) Latakia (EMSC - *European-Mediterranean Seismological Centre*, 2023).

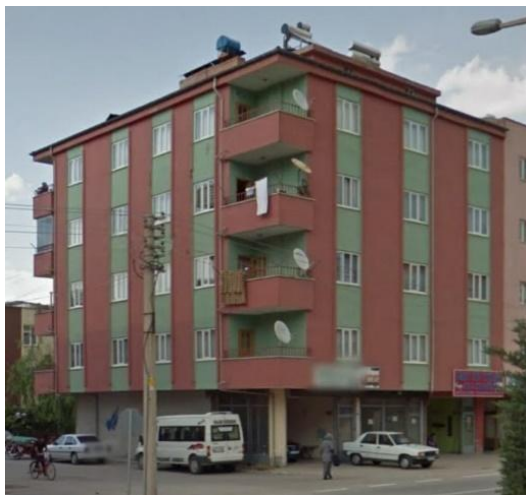
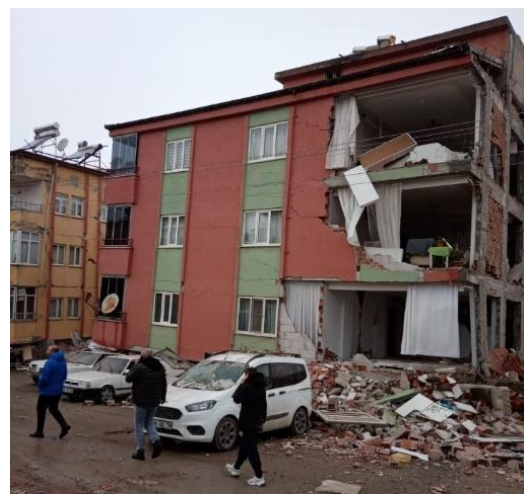
**Fig.( 11):-** Soft story failure of a 5-storey RC building with masonry infill walls in Elbistan (Alhawamdeh et al., 2023).

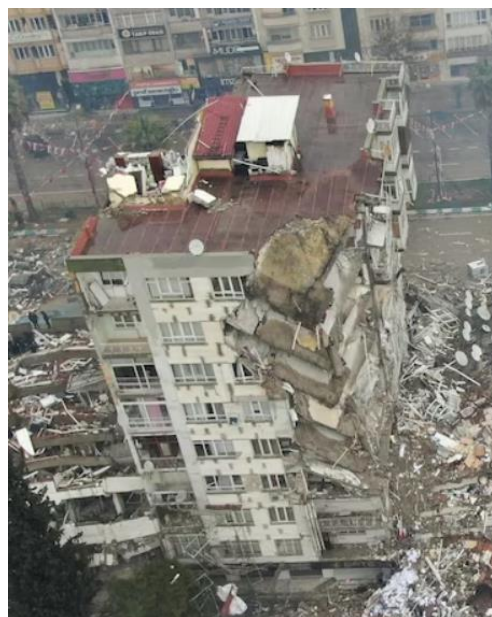
walls can all lead to an increase in torsional response during ground shaking, as shown in Figure 12 (Alhawamdeh et al., 2023).

**Fig.( 12):-** Torsion damages due to: (a) plan torsion irregularity; (b) plan with an L-shape.

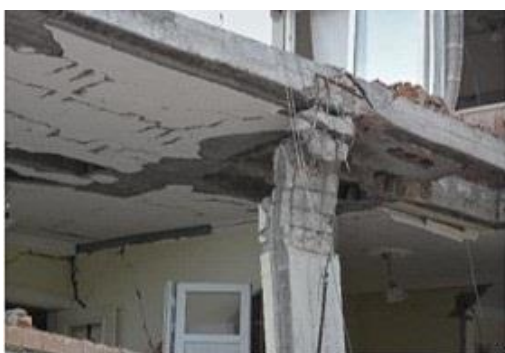
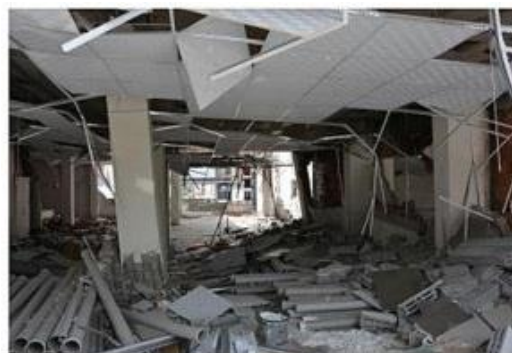
The torsion effect can also occur at the level of certain structural elements, such as the joint area between the flat slab and the column, which does not reach its capacity due to the insufficient torsional rigidity of the flat beams. Columns

narrower than flat beams can also cause beam reinforcements to be located outside of the column. This situation also creates a bonding problem in the connection region (see Figure 13) (OZTURK et al., 2023).

**Fig.( 13):-** Severe damage to RC buildings with infilled ribbed or flat slab (OZTURK et al., 2023).

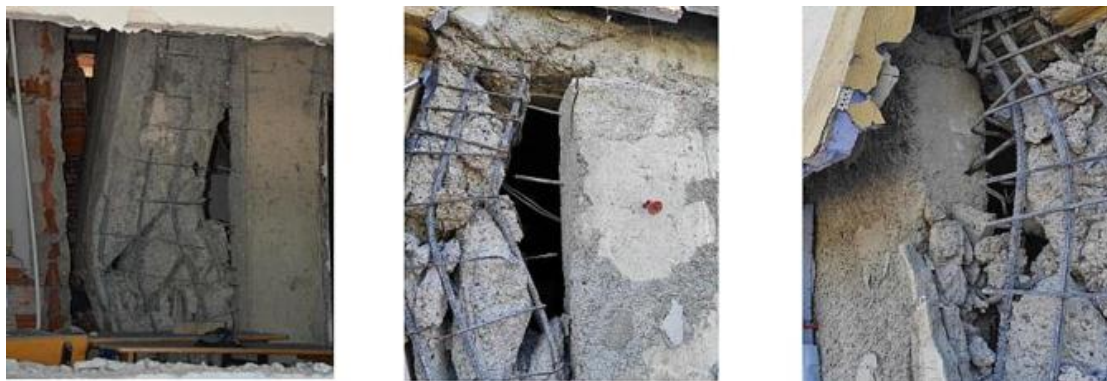
Inadequate strengthening procedures in existing buildings have also caused significant damage in these retrofitted buildings, due to both design and construction mistakes. Some columns

suffered severe torsional shear damage as a result of separation between the old columns and the new added shear walls (see Figure 14) (OZTURK et al., 2023).

Fig.( 14):- Earthquake-damage to a retrofitted high school building in Kahramanmaraş (OZTURK et al., 2023).

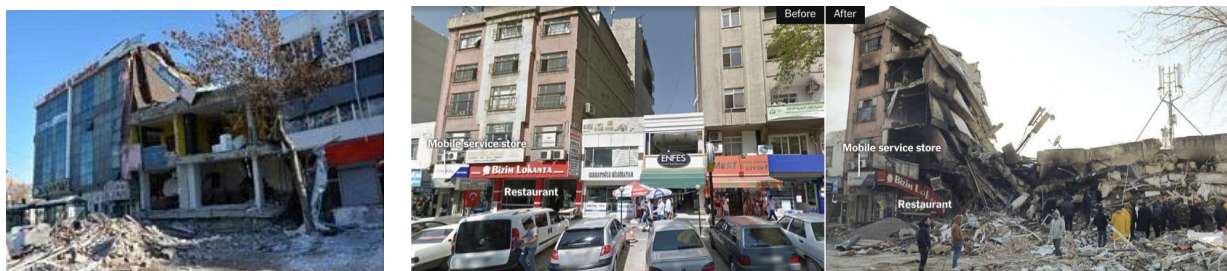
The lack of sufficient seismic gaps between adjacent buildings can lead to significant damage that may lead to collapse due to pounding effects, especially if these buildings differ in their dynamic characteristics, periods, and story heights. Neglecting the displacement

and rotation of the foundations resulting from the soil-structure interaction leads to giving the lateral displacement values of the structures less than the realistic values. Figure 15 shows damage and collapses of buildings due to pounding effects.

Fig.( 15):- Damage and collapses of buildings due to pounding effects (Alhawamdeh et al., 2023; OZTURK et al., 2023).

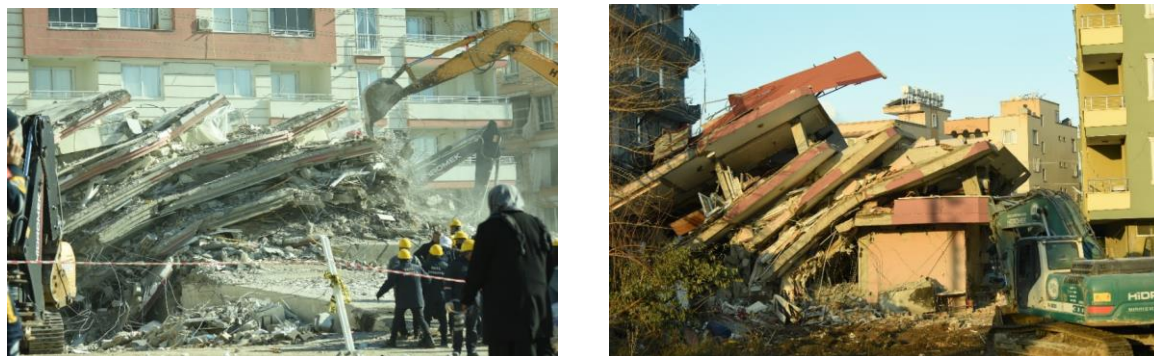
Because the vertical accelerations of the earthquakes exceeded the criteria set forth by the codes, compression failures resulting from the already inadequate concrete strength and pancake-style structure collapses occurred (OZTURK et al., 2023). And the non-compliance and inadequacy of the load bearing systems may play a major role in the occurrence of this phenomenon. Figure 17. Presents the pancake-style of building collapse.

Fig.( 17):- Damage to the load-bearing system with complete building collapse (Lekkas et al., 2023).

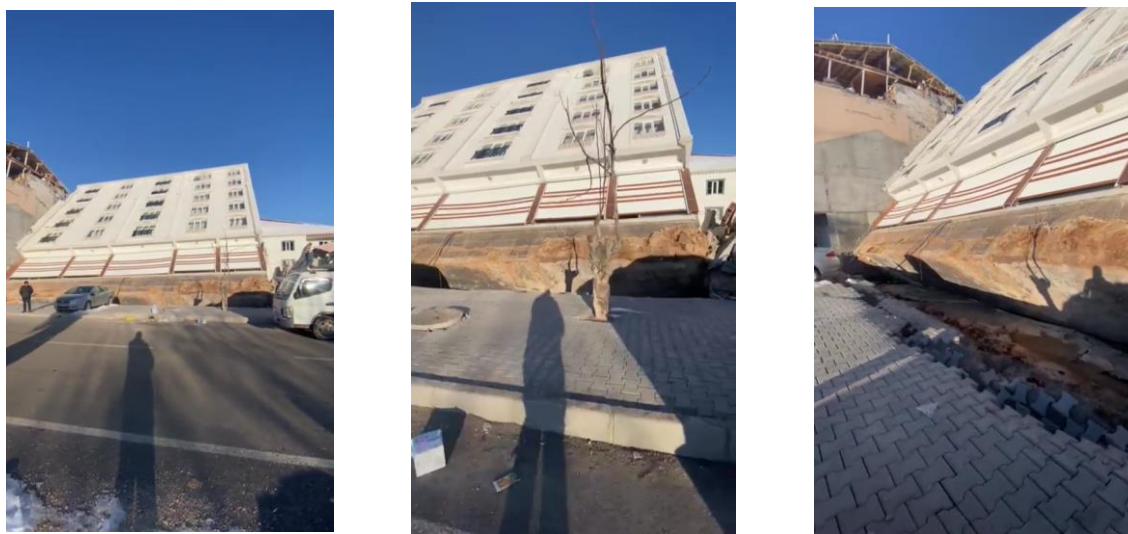
Many locations that now have high-rise buildings over them were once soft fields that were once used for agriculture. The water table was practically at the surface in these irrigated areas of the land, but it was often noted that the water was still emerging from the surface. These high-rise buildings' foundation systems can be safely categorized as "unsuitable" since they are too shallow (indicative, noted to be (where possible) between 0.50 and 0.60 meters), lacking the appropriate surface area for soil quality/conditions, and inadequately designed. A basic estimate of the foundation soil's strength predicts a tolerable bearing pressure of 40 to 50 kPa, whereas seismic excitation imposes 400 to 600 kPa or around 10 times the pressures that the

specific type of earth can withstand (Lekkas et al., 2023). Figure 18 presents the liquefaction

**Fig.( 18):-** Liquefaction phenomenon tilted the building with no damage on the upper floors (Lekkas et al., 2023).
