## SOME OF RECOMMENDATIONS AND LEARNED LESSONS FROM BUILDINGS' PERFORMANCE DURING THE RECENT TURKEY-SYRIA EARTHQUAKE

RANIA AL-AHMAR\* MAYADA AL AHMAD AL KOUSA\*\* and GEORGE WARDEH\*\*\*

### ABSTRACT

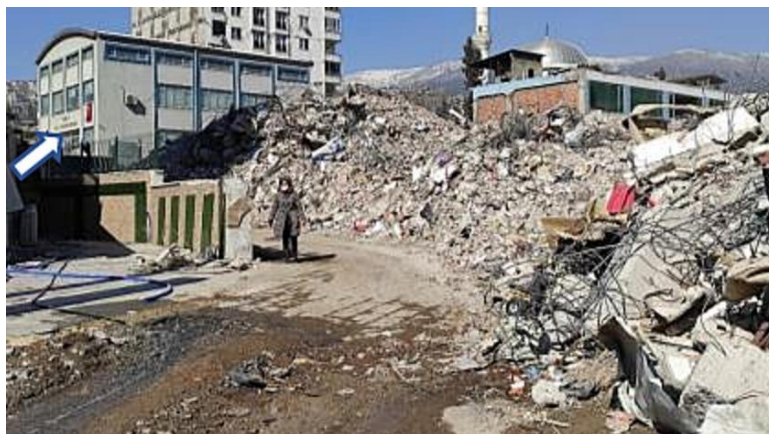
Buildings in the areas affected by the Turkey-Syria earthquake responded differently, ranging from complete or partial collapse, to severe, moderate, or minor damage, or just cracks, while other buildings remained intact without any damage. Structures can be classified according to the date of their construction and their dependence on seismic codes in their design into old structures and newer structures (Lekkas et al., 2023). Figure 1 shows an example of buildings that were not damaged as a result of the good quality of both design and construction, which is Kahramanmaraş Chamber of Civil Engineers building (indicated by an arrow), while damaged buildings with completely collapse were appeared beside it.

**Fig.( 1):-** The difference in the seismic response and damage of adjacent buildings, Kahramanmaraş (OZTURK et al., 2023).

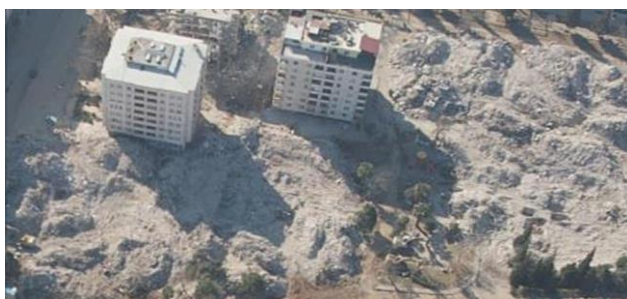
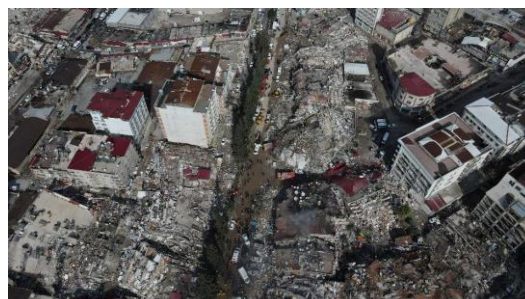
river-extracted, shiny and smooth aggregates and gravels, and inadequate compacting during concrete placement. As well as the reinforcing steel bars, which did not have any trace of cement paste left on their surface, which can be explained by the poor quality of the concrete with the insufficient amount of cement. The effect of reducing the compressive strength of concrete is more significant in columns compared to slabs and beams, where the axial forces dominate the behavior of the columns. Because of the poor quality of the concrete, many of buildings are completely collapsed and become like piles of gravel and sand (Lekkas et al., 2023; OZTURK et al., 2023), as shown in Fig. 2.

**Fig.( 2):-** Wreckages of destroyed buildings resemble heaps of sand and gravel (Lekkas et al., 2023; OZTURK et al., 2023).

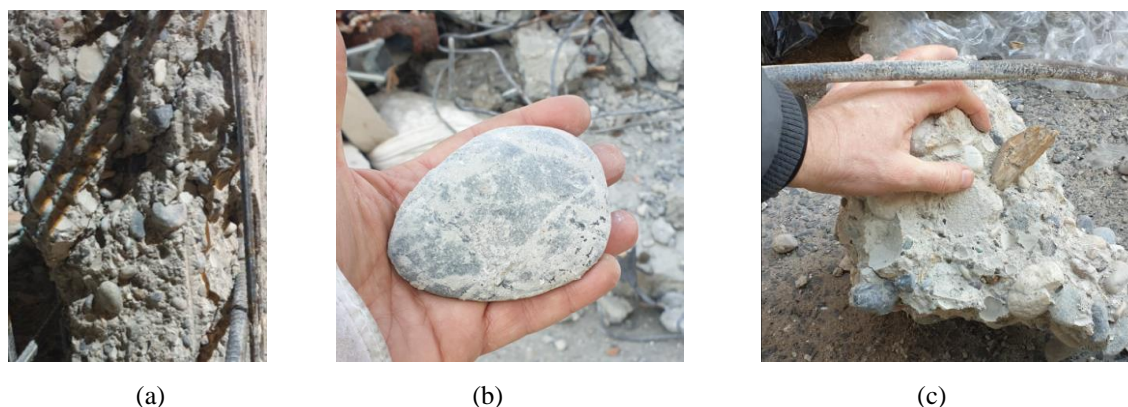
dates of issuance of modern seismic codes (Mertol et al., 2023). Figure 3 shows that most of the concrete of the ruins of collapsed and

severely damaged buildings contains round aggregates, large aggregates with diameters ranging between 50 and 100 mm, in addition to the presence of materials such as wooden pieces

within the concrete. All of these observations reduce both the resistance of the concrete and the bonding between concrete and reinforcements (Mertol et al., 2023).

**Fig.( 3):-** Poor quality of concrete: (a) aggregates having round shapes; (b) oversized aggregates; (c) Woodcuts in concrete. (Mertol et al., 2023)

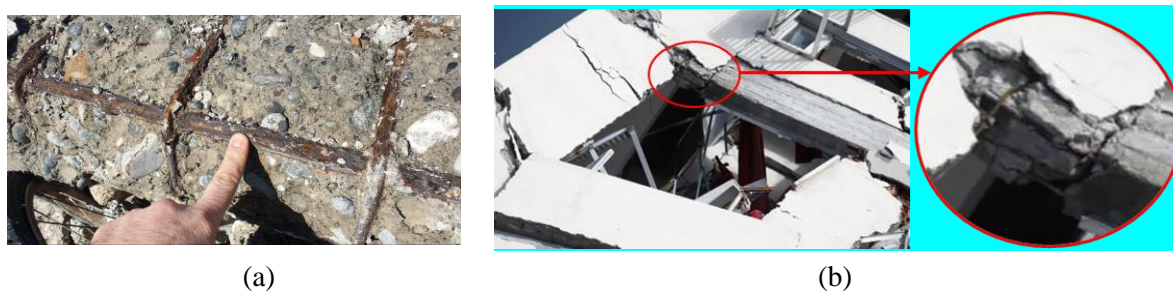
structural performance under static and dynamic loads (Yu et al., 2017). Extensive corrosion was seen in the longitudinal and transverse reinforcements of some of the severely damaged or collapsed buildings (Mertol et al., 2023). The cause of corrosion may also be because the owner of the building does not pay enough attention to its structure. For instance, not taking proper corrosion precautions in a building subject to corrosion (OZTURK et al., 2023). Figure 4 shows corrosion in stirrups, longitudinal rebars, and beam-column joints which reduce the connection ductility during earthquake sequence.

**Fig.( 4):-** Corrosion in: (a) longitudinal and transverse reinforcements (Mertol et al., 2023); and (b) beam-column connection (Alhawamdeh et al., 2023).

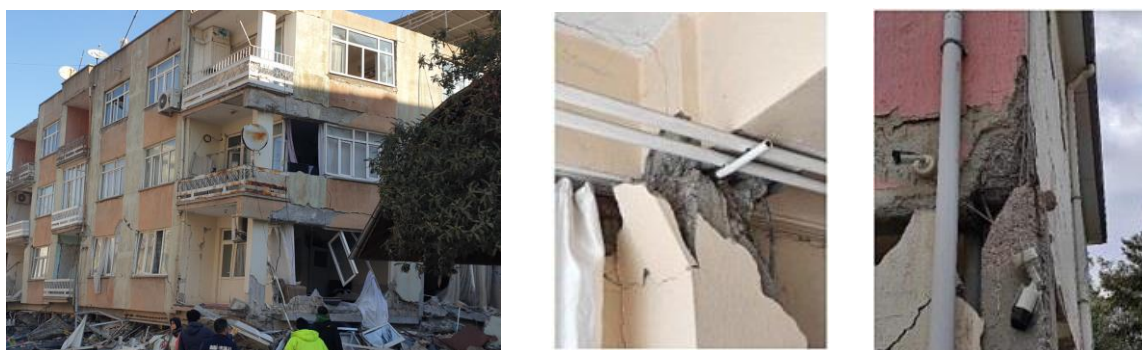
joints between the columns and the horizontal elements (beams or slabs) were also insufficient, which canceled their supposed resistance, resulting in structural deficiencies (Lekkas et al., 2023). The reason for column collapses in many buildings may be due to a lack of achievement of the concept of a weak beam and strong column using the capacity design concept. See Figures 5 and 6 for more details.

**Fig.( 5):-** collapse and damage due to strong beam and weak column (Mertol et al., 2023; OZTURK et al., 2023).

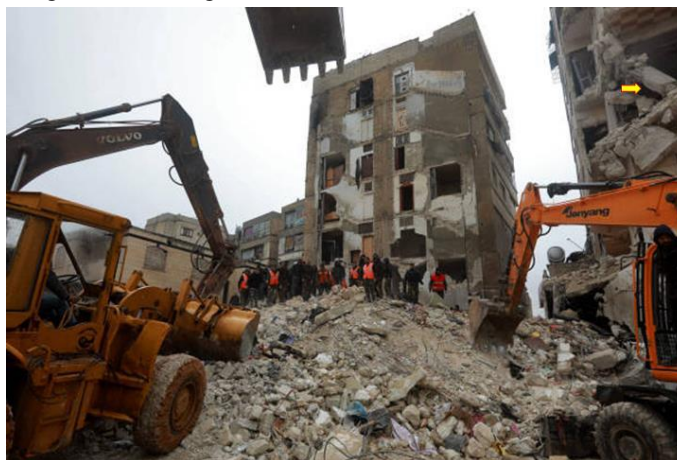
**Fig.( 6):-** Extensively damaged RC columns (marked by arrows) in a building adjacent to ruins of a collapsed building in Hama (Alhawamdeh et al., 2023).

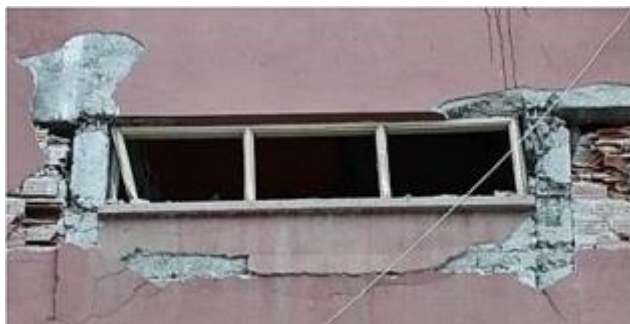
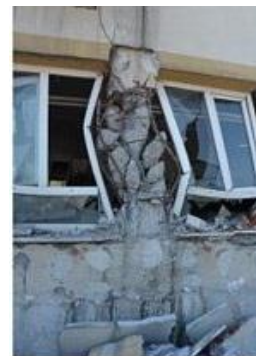
between columns in infill walls are some of the reasons for the appearance of the short column problem. Shear damage is unavoidable because this column is subjected to a higher shear force than was anticipated during the design phase (Fig. 7). The design of these short columns must be based on the approach of capacity design and take into account the requirements of the transverse reinforcement (OZTURK et al., 2023).

**Fig.( 7):-** Damage due to the short column formation in some buildings (OZTURK et al., 2023).

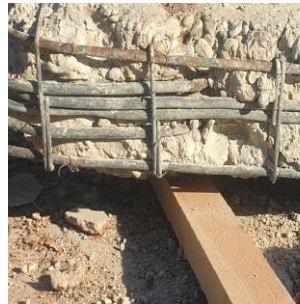
As shown in Figure 8 inadequate lap splice and anchor lengths, transverse reinforcement, and beam-column joints with insufficient shear

capability cause building collapses and considerable damage (Alhawamdeh et al., 2023; Mertol et al., 2023; OZTURK et al., 2023).

**Fig.( 8):-** Examples of inadequate: (a) anchorage length in beam (OZTURK et al., 2023); (b); transverse reinforcement (OZTURK et al., 2023); (c) stirrup ends' bend (Mertol et al., 2023); and (d) beam-column joint (OZTURK et al., 2023).

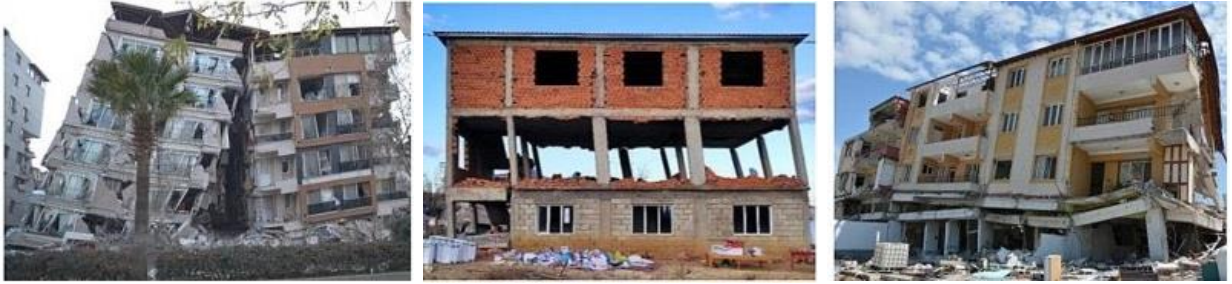
One of the most important causes of collapse and damage to reinforced concrete structures during earthquakes in all countries of the world is the soft story and the weak story problems (see Figure 9). The ground stories are generally used for commercial purposes or parking garages, and the heights of the ground stories are higher than the other stories. Lateral displacements are increased in soft stories due to the removed backfill walls and depending on the decrease in the lateral stiffness of the columns due to the height of the floors. In addition, sudden changes in the strength and stiffness of

**Fig.( 9):-** Collapses resulting from soft or weak stories in RC buildings (OZTURK et al., 2023).

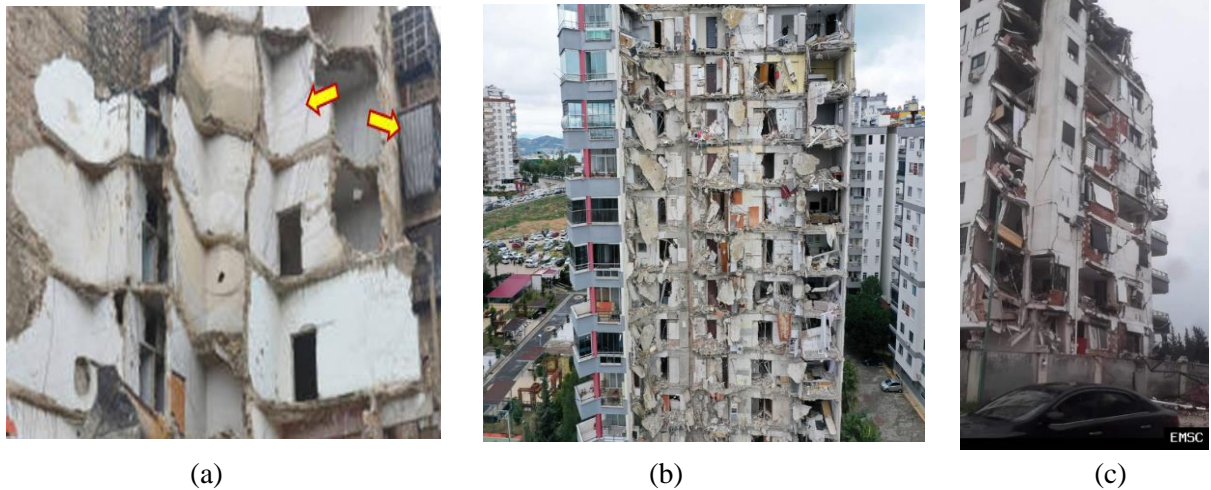
story mechanism or out-of-plane (OOP) construction failure, as displayed in Figure 10 (Alhawamdeh et al., 2023; OZTURK et al., 2023) and Figure 11 (Alhawamdeh et al., 2023). Where the collapse of infilled or masonry walls during the first earthquake can lead to the formation of weak and soft stories, which can lead to building collapse during the second earthquake or the aftershocks between them.

**Fig.( 10):-** Collapse of masonry or infilled walls of buildings in: (a) Aleppo (Alhawamdeh et al., 2023); (b) Adana (Lekkas et al., 2023); and (c) Latakia (EMSC - European-Mediterranean Seismological Centre, 2023).

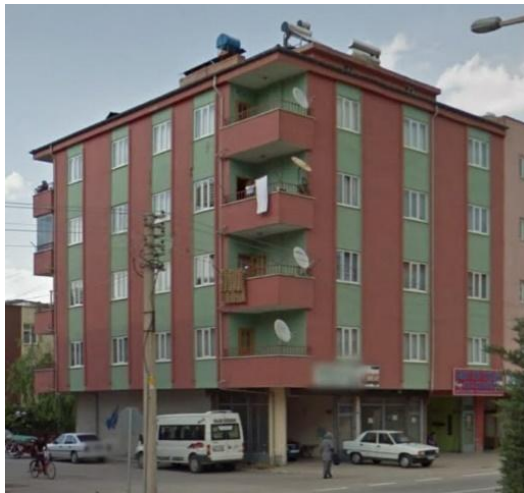
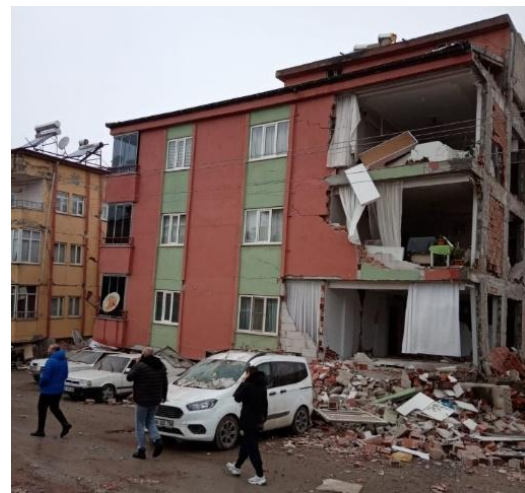
**Fig.( 11):-** Soft story failure of a 5-storey RC building with masonry infill walls in Elbistan (Alhawamdeh et al., 2023).

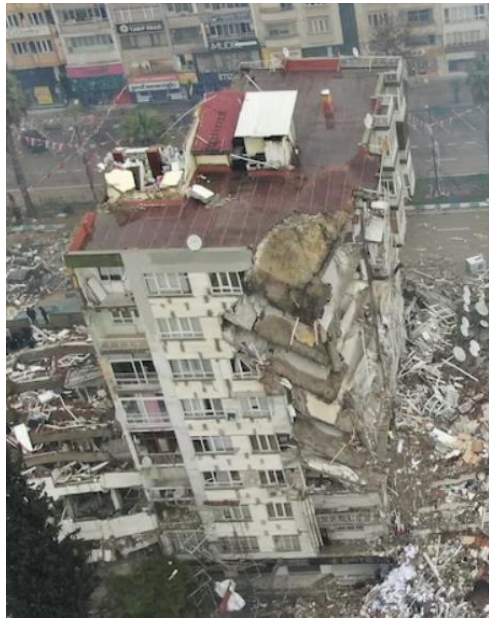
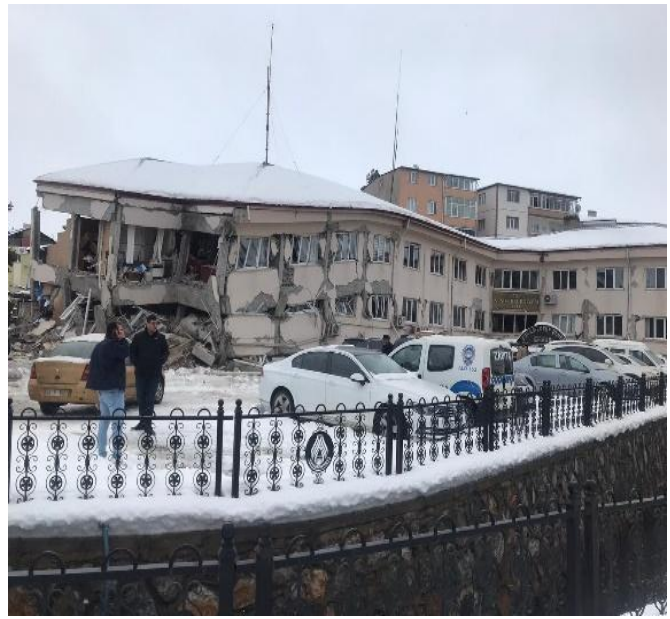
walls can all lead to an increase in torsional response during ground shaking, as shown in Figure 12 (Alhawamdeh et al., 2023).

**Fig.( 12):-** Torsion damages due to: (a) plan torsion irregularity; (b) plan with an L-shape.  
(Alhawamdeh et al., 2023)

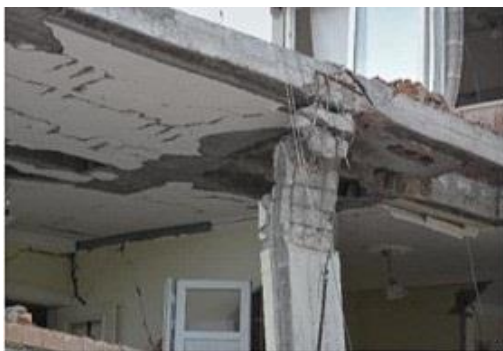
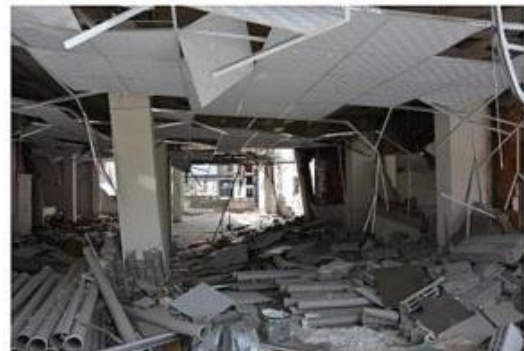
narrower than flat beams can also cause beam reinforcements to be located outside of the column. This situation also creates a bonding problem in the connection region (see Figure 13) (OZTURK et al., 2023).

**Fig.( 13):-** Severe damage to RC buildings with infilled ribbed or flat slab (OZTURK et al., 2023).

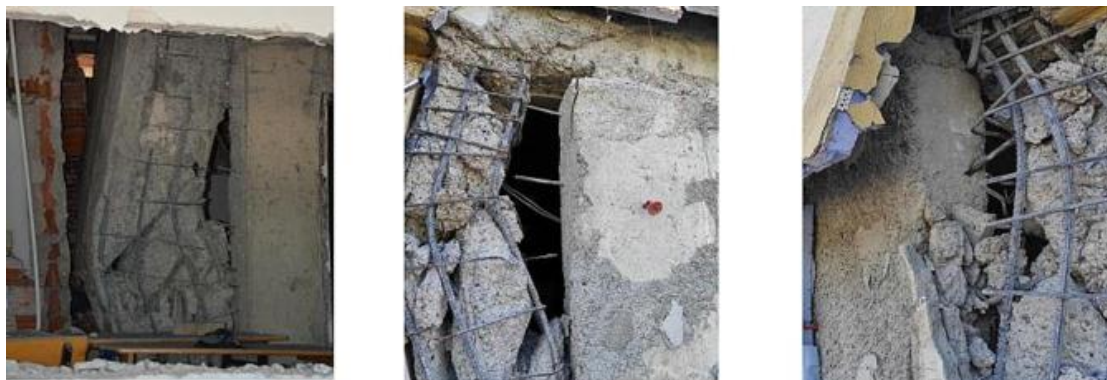
suffered severe torsional shear damage as a result of separation between the old columns and the new added shear walls (see Figure 14) (OZTURK et al., 2023).

Fig.( 14):- Earthquake-damage to a retrofitted high school building in Kahramanmaraş (OZTURK et al., 2023).

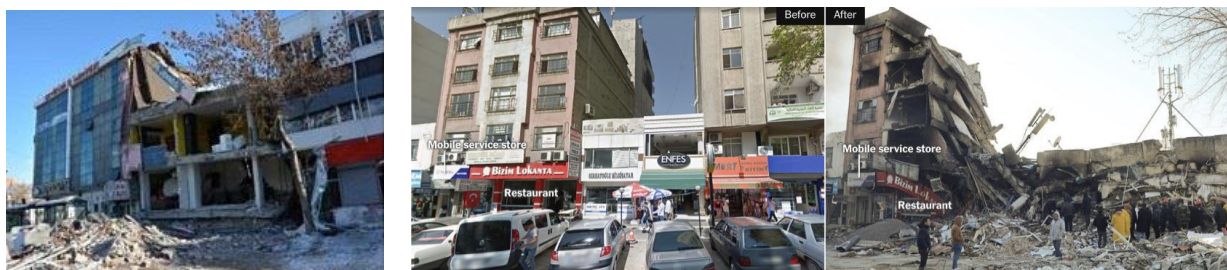
The lack of sufficient seismic gaps between adjacent buildings can lead to significant damage that may lead to collapse due to pounding effects, especially if these buildings differ in their dynamic characteristics, periods, and story heights. Neglecting the displacement

and rotation of the foundations resulting from the soil-structure interaction leads to giving the lateral displacement values of the structures less than the realistic values. Figure 15 shows damage and collapses of buildings due to pounding effects.

Fig.( 15):- Damage and collapses of buildings due to pounding effects (Alhawamdeh et al., 2023; OZTURK et al., 2023).

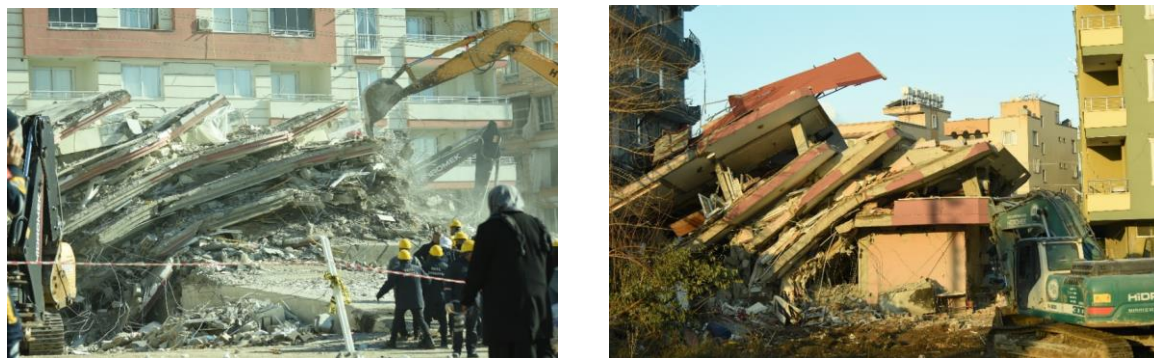
Because the vertical accelerations of the earthquakes exceeded the criteria set forth by the codes, compression failures resulting from the already inadequate concrete strength and pancake-style structure collapses occurred (OZTURK et al., 2023). And the non-compliance and inadequacy of the load bearing systems may play a major role in the occurrence of this phenomenon. Figure 17. Presents the pancake-style of building collapse.

Fig.( 17):- Damage to the load-bearing system with complete building collapse (Lekkas et al., 2023).

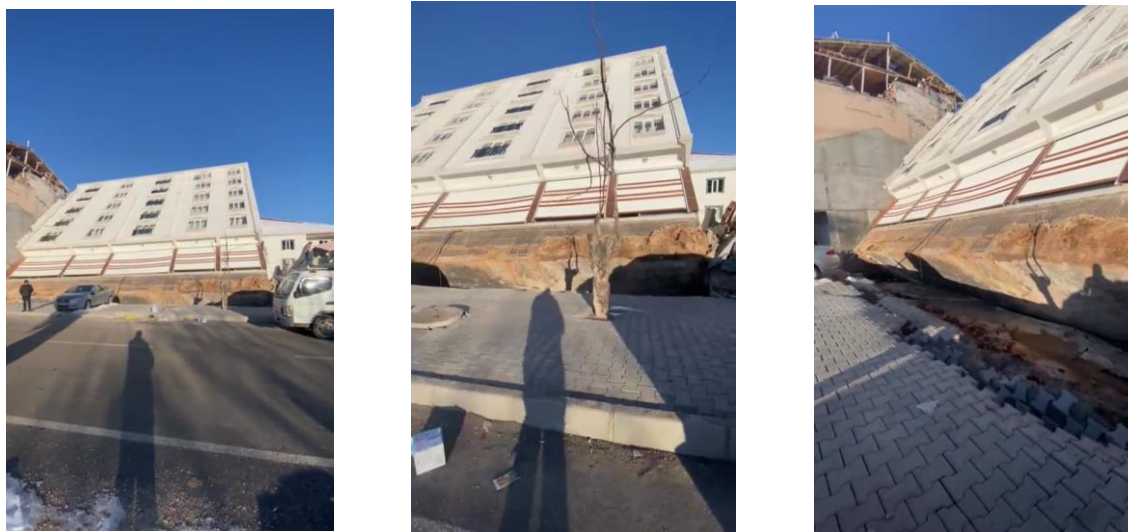
Many locations that now have high-rise buildings over them were once soft fields that were once used for agriculture. The water table was practically at the surface in these irrigated areas of the land, but it was often noted that the water was still emerging from the surface. These high-rise buildings' foundation systems can be safely categorized as "unsuitable" since they are too shallow (indicative, noted to be (where possible) between 0.50 and 0.60 meters), lacking the appropriate surface area for soil quality/conditions, and inadequately designed. A basic estimate of the foundation soil's strength predicts a tolerable bearing pressure of 40 to 50 kPa, whereas seismic excitation imposes 400 to 600 kPa or around 10 times the pressures that the

specific type of earth can withstand (Lekkas et al., 2023). Figure 18 presents the liquefaction

**Fig.( 18):-** Liquefaction phenomenon tilted the building with no damage on the upper floors (Lekkas et al., 2023).
