REFLECTIONS OF HALABJAH EARTHQUAKE EFFECTS ON THE STRUCTURAL BUILDING DAMAGES IN HALABJAH AND DARBANDIKHAN

WRYA ABDULLAH¹, SERWAN KHORSHEED RAFIQ and YOUNIS M. ALSHKANE
College of Engineering, University of Sulaimani, Kurdistan Region-Iraq

(Accepted for Publication: December 8, 2020)

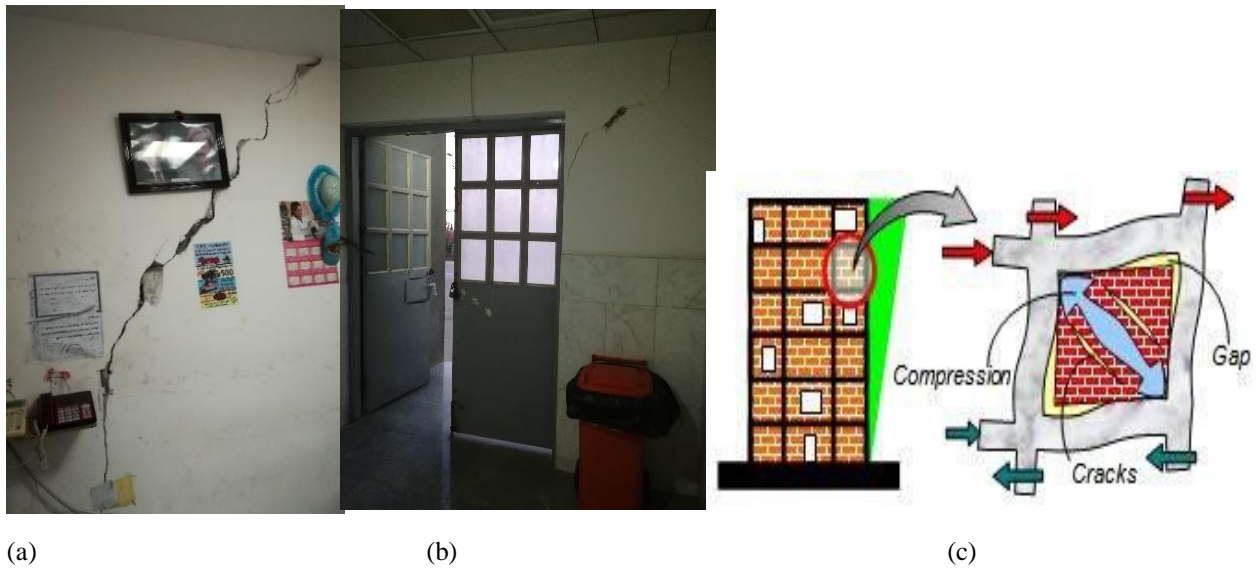
Halabjah is located 14 km away from the Iranian border. It is one of the cities in Kurdistan Region of Iraq which is at 35°11'11" N 45°58'26" E. The epicenter of the quake was only 30 km away from Halabjah. During the site investigation visit, no serious damages were observed in buildings in Halabjah, even though, the name of was attributed it based on (USGS, 2017a). The most common types of damage in Halabjah was cracking of infill walls due to the to and fro motion of the buildings during the earthquake. These cracks can be seen in the R.C frame buildings and in partition walls as they transfer the lateral loads from beam-column joints of the upper floor to the one beneath working like a brace that will be exposed to a huge compression force during an earthquake as it can be seen in Figure 4 (c). Also, because those infill walls were made out of concrete blocks, they are weaker than concrete in compression and as a result they develop cracks. These types of cracks are usually diagonal for the reasons mentioned. Examples of the cracks were observed in Halabjah Children Hospital as it can be seen in Figures 4 (a) and (b). The possible solution recommended by ASCE/SEI, (2007) for these walls is repairing of the finishing with blocking the crack using epoxy or strong mortar injection (ASCE/SEI, 2007). The

(a) (b) (c)
Fig. (4): (a) and (b): Cracks in infill walls in Children Hospital in Halabjah (c) Illustration of how infill walls work during an earthquake (Murty, 2004c)

detailed procedure is described by (Dehghani et al., 2015) as it can be done by peeling off the whole cracked finishing surface from both sides and repairing the cracks by filling them with strong mortar then carrying out the finishing on both sides once the mortar dried out. This solution is considered as sufficient, as the main function of infills are to be used as partitions otherwise the whole load is carried by the frame. In fact, they are deliberately built to damage during an earthquake to dissipate some energy based on (Eurocode 8, 2004).

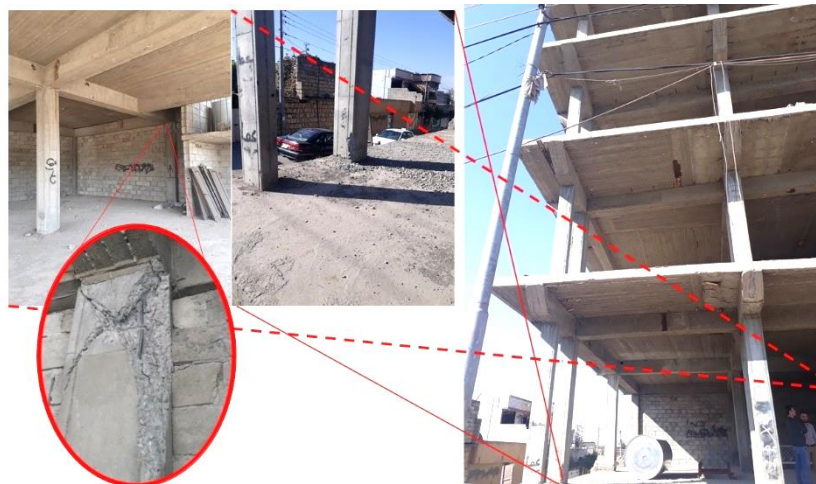
There were some column hinges formed in some of the commercial R.C frame buildings in the area such as that shown in Figure 5 and Figure 6. This type of failure can be explained as the building is not designed to resist earthquake loads and the principle of strong column- weak beam was not followed to prevent collapse. Also, the concrete used for the columns could crumble easily using a little force of a hand so the columns could not resist the shear force on them as the concrete was extremely weak. The authors confirmed that the concrete of the columns could easily come off by using a force as little as a kick as it can be seen in Figure 6. Therefore, due to the oscillation of the building and stiffening the building with masonry walls, the column ends were not free to displace and as a result those hinges were formed. As for retrofitting the columns of this building, some methods are proposed such as using steel caging and PTMS which is post tension metal strap and it is widely proven that it will retrofit the columns easily (Chin et al., 2020; Garcia et al., 2014; Helal, 2012). The method works by tying high tensile strength steel straps around affected areas of the columns using a pneumatic machine for tensioning and then clipping the ends to fix them. Another method is using I section columns next to the existing ones to support them in carrying the gravity loads already on the columns.

Fig. (5): Damage in a column of a 7-story reinforced concrete building in Halabjah

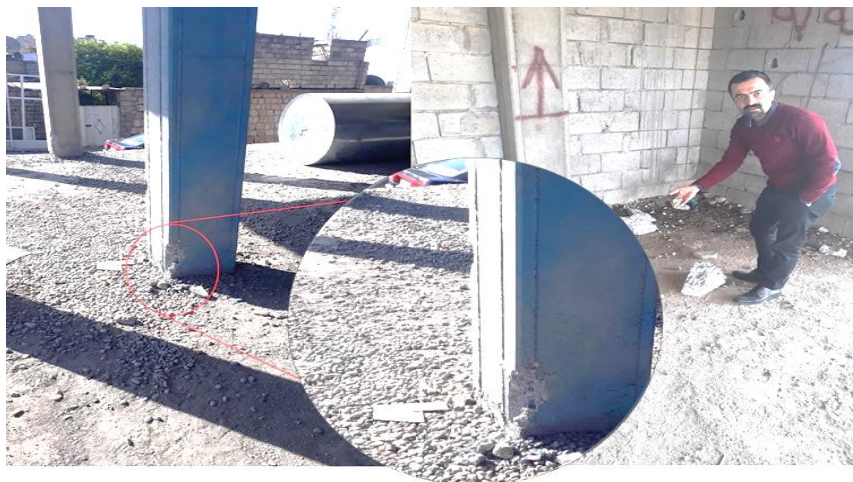
Fig. (6): Easily crushing the concrete by one of the authors as a sign of very weak concrete

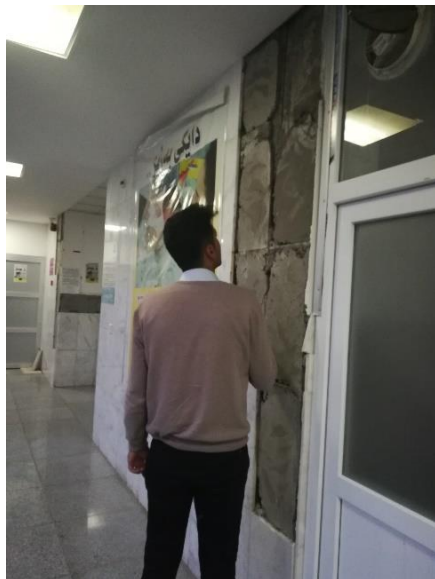
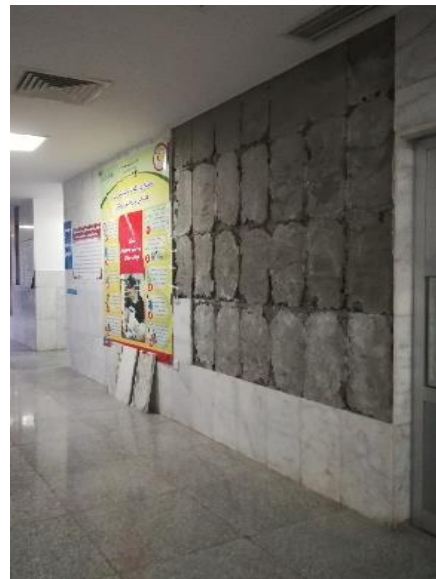
Another common type of damage in both Halabjah was using massive tiles for finishing and Hilan stone for cladding. So, during the earthquake most of the tiles were fallen off because of the vibrations as it is clear in Figure 7 which are the walls of a Hospital in Halabjah. This has led to evacuating the hospital as it caused panic among the staff and patients of the hospital. The irony in this case is that during earthquakes, hospitals must remain fully operational and functional yet they locked down the hospital for hours.

As it can be seen form Figure 7. the status of the concrete block walls was stable as no cracks can be observed in them to point for a failure, therefore, the possible reason for falling the tiling is poor construction and using weak mortar as only the tiles are affected not the walls. Therefore, the solution is to mount new tiles on all the walls again using stronger mortar or change it to gypsum plastering as it is more

Fig. (7): Falling of heavy tile finishing inside the Children Hospital in Halabjah

suitable in terms of construction.

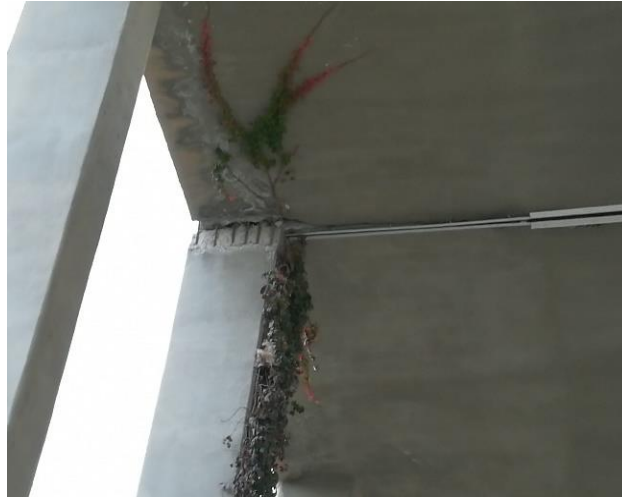
Last type of damage noticed by the authors was in Halabjah Children Hospital and it was the pounding effect happened between the construction joint of the building as it can be seen in Figure 8. This is because the space of the joint was not large enough to house the displacement of the top floor and caused hammering between the two parts of the buildings when they displaced towards each other during the earthquake. The possible solution is to renovate the construction joint and grout the concrete cover of the columns using stronger mortar as the reinforcements were exposed to the air. The columns were in front of the hospital and the load on them was not heavy enough to cause worries but still repairing was needed.

Fig. (8): Pounding effect between two columns in the Children Hospital in Halabjah

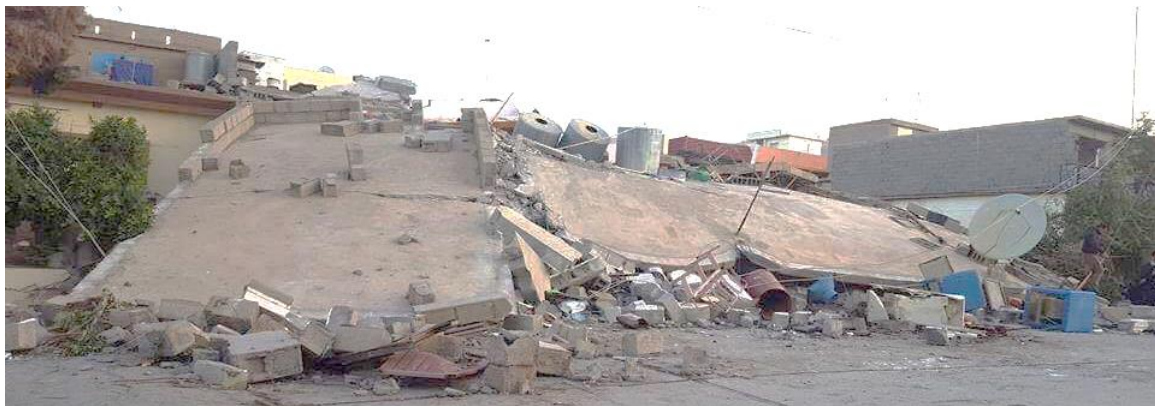
Numerous factors can contribute in collapsing of these buildings. For instance, in the building shown in Figure 9, which was a two-storey building with a frame base and two masonry floors, apart from using two different systems combined, the mass of the slab and very deep lintels over windows and doors were accumulated in front of building as it can be seen in Figures 10 and 11. This caused it to have more inertia forces during the earthquake and because the upper story was masonry so there was not

enough connection between the slab and the supports as to provide the stiffness needed to balance for the inertia forces based on the illustrations in Figure 13. As a consequence, the slab slipped off on the supports and caused the total collapse of the building. Another factor that added to the causes of the total collapse might be the soft storey effects. Because the ground floor was an open area supported only by long columns that was higher than the other floor as it was used as a storage area. Therefore, based on the analogy of the illustrations in Figure 14, it can be concluded that the mass of the first floor of the building was accumulated on top of the ground floor as lumped mass to create an inverted pendulum that caused a huge unbearable drift due to large amount of inertia force that caused the total collapse. Other factors might be irregularities in the plan of the building, as it can be seen from Figure 9, where the left-hand side of the building was longer, which was extending for the whole length of the land of 20 m, wider with a width of nearly 5 and taller, with an estimated height of at least 6 m as it was double spaced used as a parking area as the witnesses reported three buried cars under the rubble of the building, than the right hand side of the building. Because of this, it required a huge slab thickness of an estimate of 25 to 30 cm with very deep lintels with the depth of nearly 80 to

Figure 9. Collapse of a three-story Building using Hybrid system of (R.C Frame- Masonry) (front view)

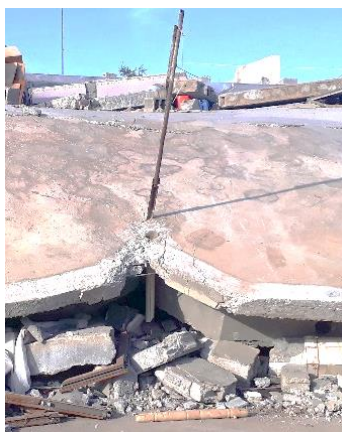
100 cm all over the front of the building. This shifted the center of mass of the whole building towards the left-hand side and front of the building. Therefore, it was less stiff than the right-hand side so it caused a notable rotation of the whole building. Also, three water tanks can be seen in Figure 9 on the roof top which adds the weight to the roof and can cause drift of the roof by increasing the inertia forces. There are other factors which related to the lack of the details of traverse reinforcement of the columns as it can be seen in Figure 12. Also, the quality of the concrete appears to be not satisfactory enough as it did not resist any shear forces of the columns and a clear cut can be observed in Figure 12 which is a sign of not resisting the

Fig. (10): Large R.C lintels of depth of more than one meter in front of the house

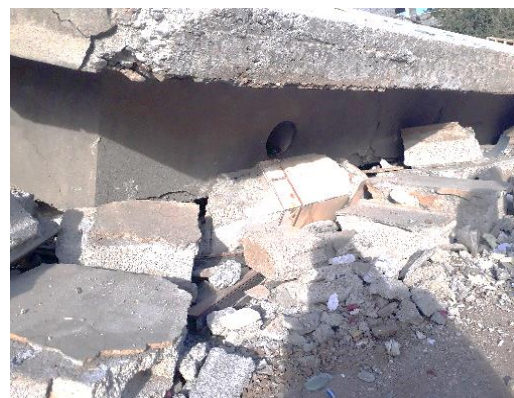
Fig. (11): the scale of the lintel compared to a 40 cm concrete block

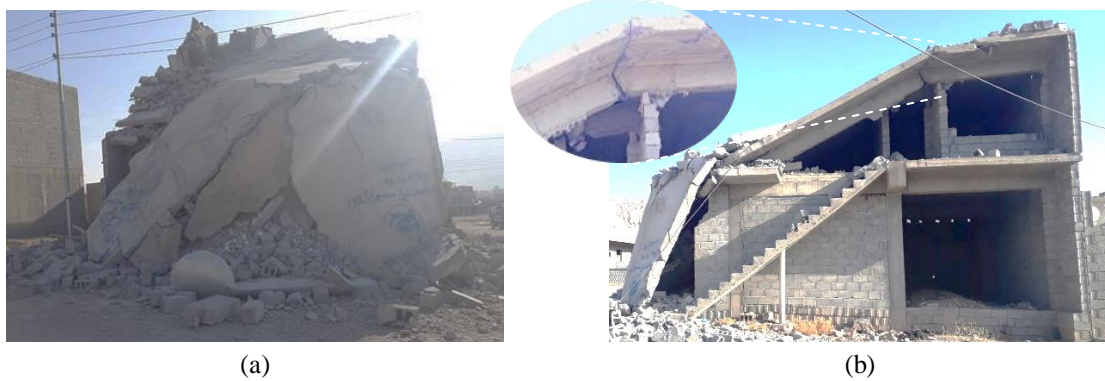
Another building hybrid of a three storey in Darbandikhan, shown in Figure 15, was collapsed due to several reasons apart from using the hybrid system. Most of the above reasons such as strong beam-weak support, asymmetry in plan, and huge slab mass are still true for the failure of this building. Also, Figure 15 (b) shows the side view of the building, and it can be seen that the building was spacious at the first-floor level and there was barely a wall to support all the beam and slab masses. Moreover, it was obvious that the cantilever slab of the first floor in front of the building had a circular long column with an estimated length of 6 m that was used to support the weight of the slab along with those little brittle walls at the end of both sides the of first floor. Because the mass of the building was not distributed evenly as the back

of the building had an irregular extra floor, as it can be seen in Figures 15 (a) and 16 (a), adding the mass of the back and shifting the center of mass of the building towards the back and its left hand-side. All in all, having only a long column in front and a huge mass at the back and using the analogy in shown Figure 17, it has caused a rotation of the building, especially the third floor of it, towards its left-hand side and causing the total collapse. The evidence of rotation is clear at the base of the third floor as it can be seen in Figure 16 (a). The crack patterns on the slab, which can be seen in Figure 15 (a), point to the path of the yield line of the slab as it had left with no other supports apart from the long column during the earthquake which can be seen in Figure 16 (b). This happened as, during the earthquake, the slab of the building with

Fig. (15): (a) Front view of a collapsed three-story hybrid building (b) Side view of the same building

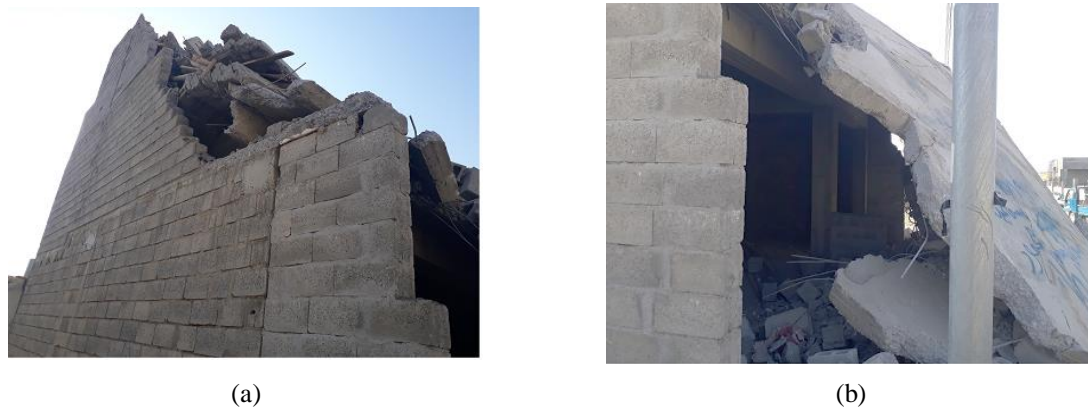
additional mass of the third floor started rotating towards left so the masonry walls, those helped the long column in carrying the weight, failed and scattered into pieces as they are brittle and the amount of the contact area was not much due to the spacious area. Concrete blocks with no cracks can be seen on the ground which points failure due to rotation. The rotation of the slab had left the column alone in carrying the weight of the slab and from the cracks of the slab it can be concluded that the column was strong enough to cause punching shear and cracks in this pattern in the slab, otherwise, the slab would have just collapse without any cracks of this pattern. Furthermore, a factor that aggravated the situation was not knowing the behavior of the

members and not detailing them correctly, for instance, as an obvious shear crack and a shear failure, which is brittle and terminal, can be seen from a short deep beam between what seems like a corridor in the first floor as in Figure 15 (b). From the remainder of the reinforcement of that beam, it can be concluded that it had reinforced as the extension of the other beam and was not treated as a deep beam therefore, it failed in shear breaking the slab into two pieces at that location. A small lintel can be seen behind the shear crack which failed in shear as the left hand-side of it scattered into pieces. These summaries the total causes of failure of this building.

Fig. (16): (a) Rotation of at the base of the third floor (b) A collapsed circular column

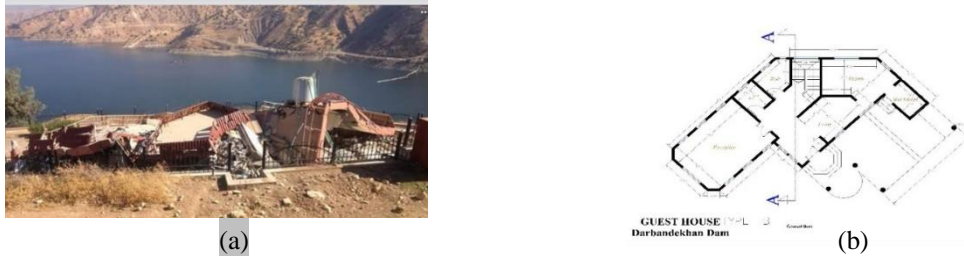
Another collapsed masonry hybrid building was a guest house of the dam shown in Figure 17. From the plan of it, shown in Figure 17 b, it can be concluded that the layout of the plan was not symmetric by using unparallel walls which

provides minimum resistance to lateral loads. Also, the columns in front of the buildings were supporting huge slabs above them without any beams or walls in between to increase their stiffnesses. A beam can be seen hanged on the

slab between two columns without having any columns or girders to transfer its load. This leads to having a huge inertia forces during an earthquake which leads to rotation of the building as it is illustrated in Figure 18 and led it to fail because of the asymmetry in the plan.

This leads to an asymmetry in the stiffness as the first floor of the building was stiffened using masonry walls, however, the ground floor was stiffened using flat slabs supported only by slender columns.

Fig. (17): (a): Collapse of two-story guest house building using (b): Plan of the building

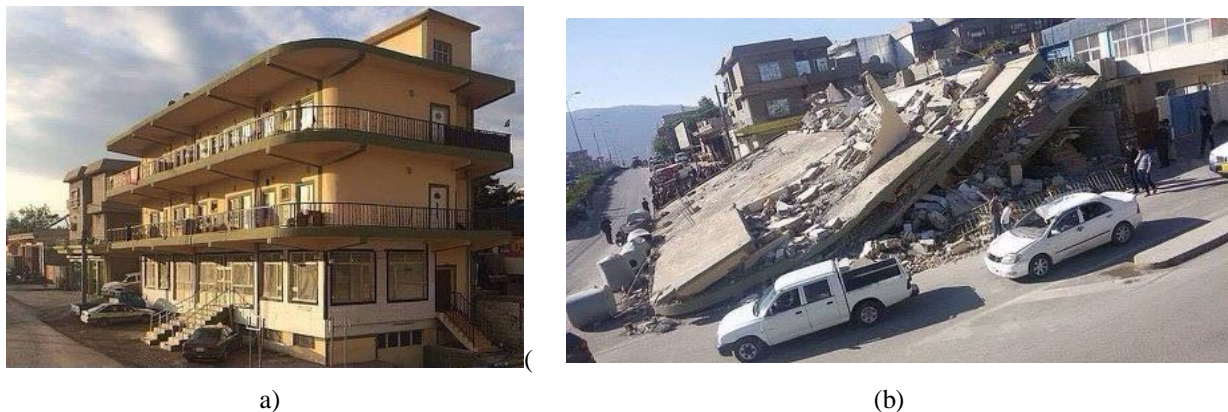
A totally collapsed R.C frame observed is shown in Figure 19. The reason of the collapse was an accumulation of short column effects in the basement and soft story mechanism on top of it at the ground floor. The short column theory suggests that for a building floor with different heights of columns, the shorter columns attract more forces as they will be stiffer and as a result, they will either explode or crack diagonally as illustrated in Figure 20. The building shown in Figure 19 had a basement for which the columns of the left-hand side were shortened to make space for windows. As a result, the left-hand side column backed with the ground and did not have a chance to displace freely as the right-hand side did. As evidence, little spaces left for windows can be seen in the basement which proves that there were long columns buried on the left-hand side. Therefore, if the building jerks suddenly from right to left then the columns on the

right-hand-side would be free to move while the motion of the columns on the left-hand side is restricted by the ground. As a result, the short columns next to the small windows exploded due to attraction of huge lateral forces as they were stiffer leading to a tilt in the building towards left hand-side, exactly where the small windows were in the basement as it can be seen in Figure 19 (b). The evidence of short column effects can be seen as the whole building collapsed towards left-hand side as in Figure 19 (b). The slab of the penthouse and water tanks can be seen on the left-hand side of the building which appears as if they were thrown this way due to the sudden failure caused by the short column effects in the basement as it can be seen in Figure 19 (b). Adding to the factors, soft storey mechanism might have been another mistake in the collapse of this building, as the first and second storey of the building were stiffer than the ground floor of

it. So, using the analogy of Figure 14, it can be argued that it has added a reason to the failure. The area moment of inertia of the building added a reason to the failure as the shape was thinner in the direction of the collapse. The aforementioned factors might have contributed in the collapse of this building as having a heavy mass on each

floor and having that slim shape which produced less stiffness in the direction of the collapse. The short column effects, was a fatal mistake in this building otherwise, the authors confirm the elements were supplied with enough reinforcements

Fig. (19 (a)). The building before collapse. (b) Collapse of Four-story R.C frame Building.

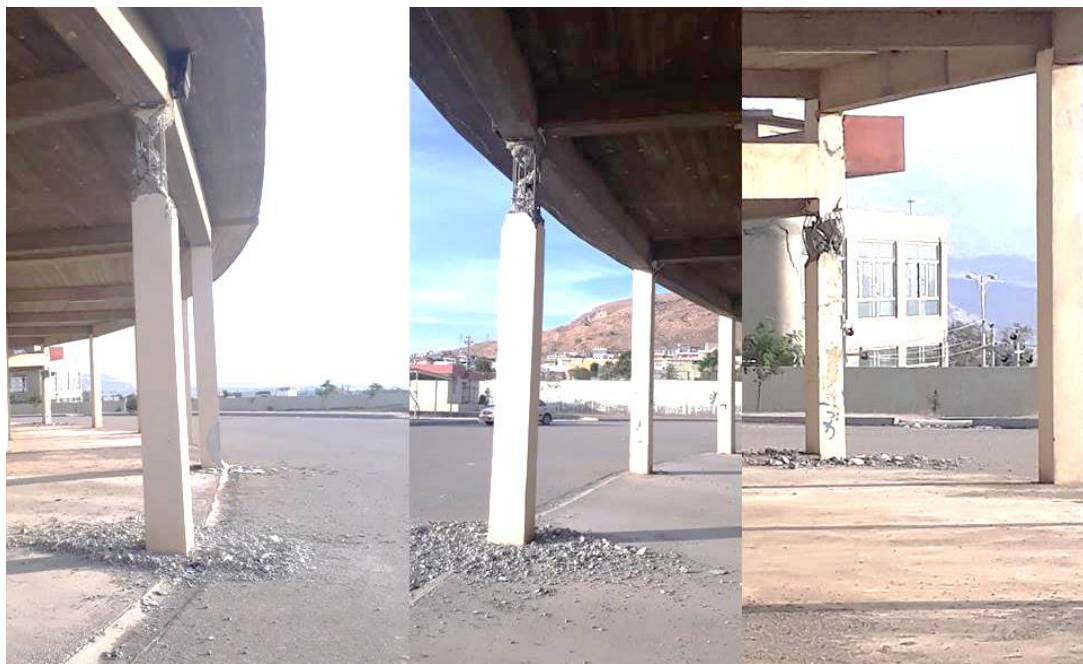
Hinges in upper end columns of Darbandikhan' main bus and taxi station was described as a "strange failure" by the locals. As it can be seen from Figure 21, only the upper part of some of columns were exploded during the earthquake. Several possible reasons contribute in having this kind of failure in the columns. First is that the upper parts of the columns displace more due to more acceleration response per height while only damping and

stiffness contribute to counteract that much of displacement. However, in this structure, the shape is an oval which provided minimum resistance as it is irregular, and it has no extra stiffness from walls as they were open spaces so the only members resisting the inertia forces were columns. Yet, that irregularity in the plan makes it vulnerable to earthquake as it has fewer number of columns aligned to provide the stiffness needed to counteract the huge inertia

forces produced by the mass of the slabs and beams. It also, causes rotations of the slabs and that was leading to sudden explosion of the top parts. Moreover, the lack of the transverse reinforcement close to beams added reasons for not having enough strength in resisting the lateral forces. It can be seen in Figure 21 that the spacing of the ties in that sensitive area was more than 40 cm which is not allowed under any circumstances. Pounding effects was another reason, as the station was huge enough to be constructed as one part therefore, it was distributed to more than three parts but with different heights which increases the effects of pounding. From figure 22, it is clear that there is a huge vertical crack between the middle columns in the middle of the photograph which is a clear sign of pounding effects. Also, the height of the floor was more than 4 m to accommodate buses and it has heavy beams and slabs on top. This would be fatal as it acts as an inverted pendulum creating a soft story and leading to such explosions. Lastly, poor quality of the concrete was argued to be another factor in hinging those columns, however, because in some of the columns only the cover of them was spalled therefore, it is believed that the lack of

confinement is the main reason not the concrete itself.

Fig. (21): Hinging in columns at exterior supports

The proposed solution was to increase the confinement of the columns. It is recommended to retrofit them using a low cost and fast method of strengthening. First the exploded vicinities have to be filled with a strong concrete where possible otherwise with a strong mortar if it was only the cover spalled. Then, the most suitable method of confinement should be selected in terms price and time of execution. The cheapest and the fastest method in increasing the confinement found in the literature is using PTMS. It is proven by so many researchers in the literature (Chin et al., 2020; Garcia, Hajirasouliha, Guadagnini, Helal, Jemaa, Pilakoutas, Mongabure, Chrysostomou, Kyriakides, Ilki, Budescu, Taranu, Ciupala, et al., 2014; Helal et al., 2016, 2016; Lopez et al., 2012; Ma et al., 2019; Moghaddam et al., 2010). Alternative methods include enlargement of the sections using section enlargement or retrofitting those columns using steel cages. In both cases, the process takes a lot of time and needs extra expenses for the labor works such as reinforcement works, molding and curing.

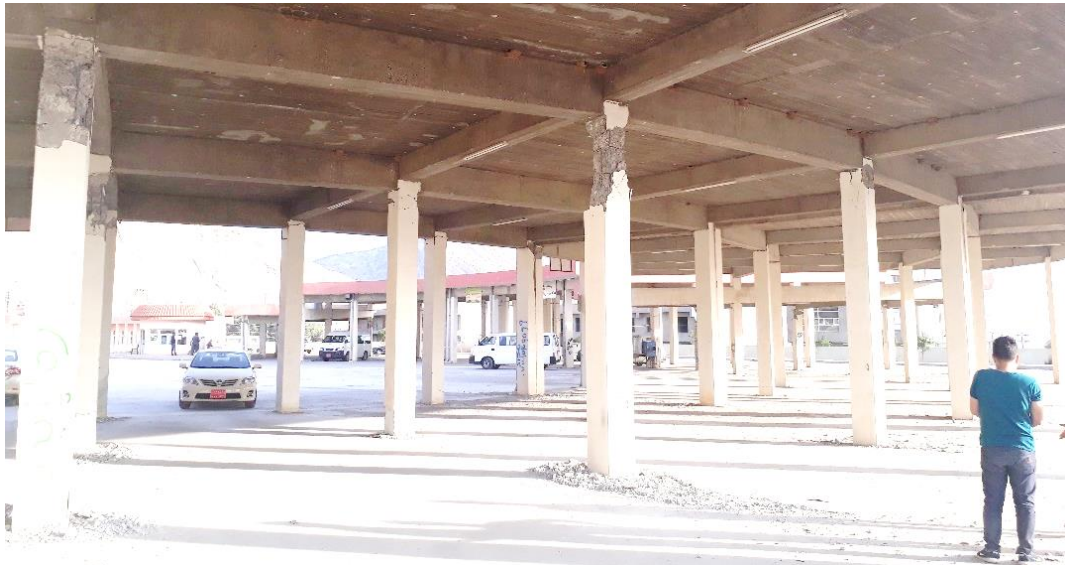
Fig. (22): Hinging in columns with an idea on the shape of the station

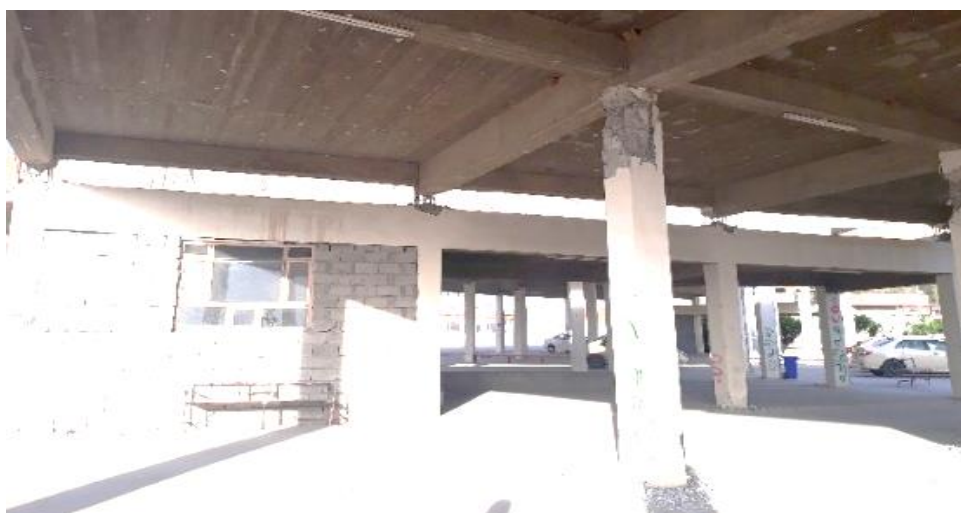
Another problem in that station and the main hospital of the Darbandikhan was having short column effects causing diagonal cracks in some of the columns as it can be seen in Figure 23. Because having a short column is very dangerous as it would explode straight away due to the large forces attracted by their huge stiffness as is illustrated in Figure 20 (Murty, 2004d). The possible solution is to eliminate having those short columns and distribute the

Fig. (23): Short column effects

stiffnesses equally. The solution for those exploded areas of the columns is to fill that gap in between the short columns with strong R.C sections like beams to act like shear walls. Also, to extend the beams on top of them onto the slab of the shorter part of the station to a certain length. Knowing that they still have to be confined with some techniques of confinement such as PTMS.

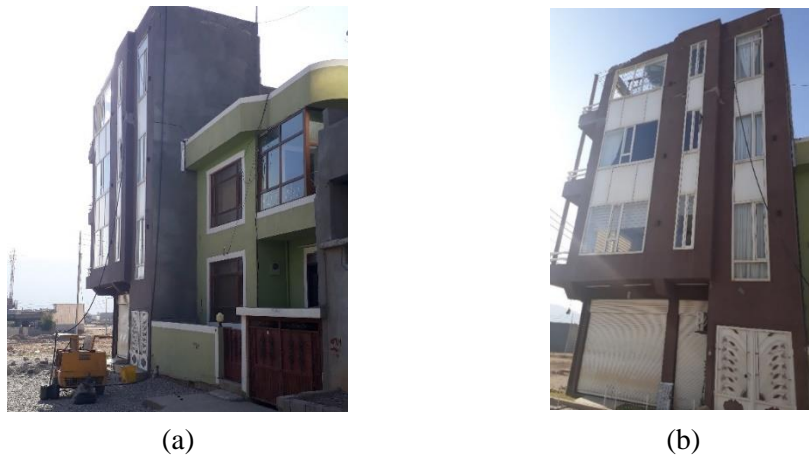
The rotation effects were clearly visible in a residential building shown in Figure 24. The

building was stable at its current state but the twist could have been seen from a distance. The

main reason of rotation is the center of mass of the building was not aligned with the center of rigidity as described by (Murty, 2004b). This can be observed from the back of the building in Figure 24 (a) that one side (left hand-side) is higher which means heavier than the other side. This caused a rotation in the whole three floors

Fig. (24): Rotation of a frame building in Darbandikhan (a) Isometric view of the building showing its back (b) Side view of the building

as it is illustrated in Figure 18. The solution for this case is prevention from the design stage and before constructing it, however, the owner of the building started demolition the last floor to reduce the gap between the center of mass and the center of rigidity.

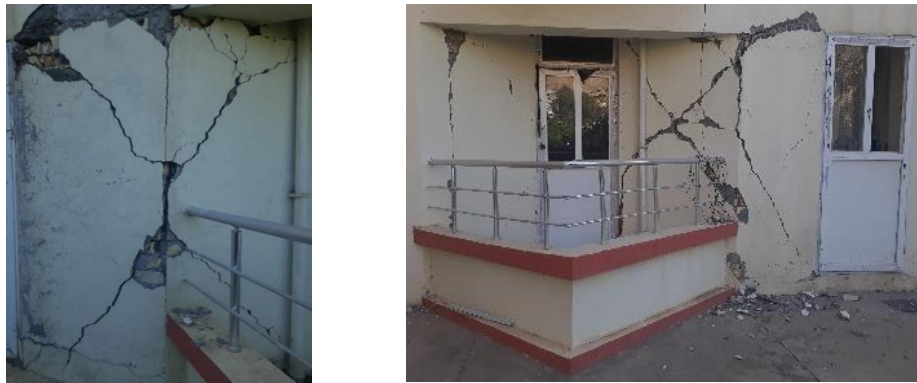
The diagonal cracks in masonry walls were frequent in the general hospital of Darbandikhan as it be seen in Figure 25. The reason for this phenomenon is explained in the previous paragraphs and illustrated in Figure 4 (c). These diagonal cracks along with falling off the finishing tiles and Hilan stone caused panic and fear amongst the staff of the hospital who evacuated the building and caused a lock down of the hospital. Two days after the earthquake and 14th of November the hospital was still closed down while it should have been

Fig. (25): Diagonal cracks in the infill walls

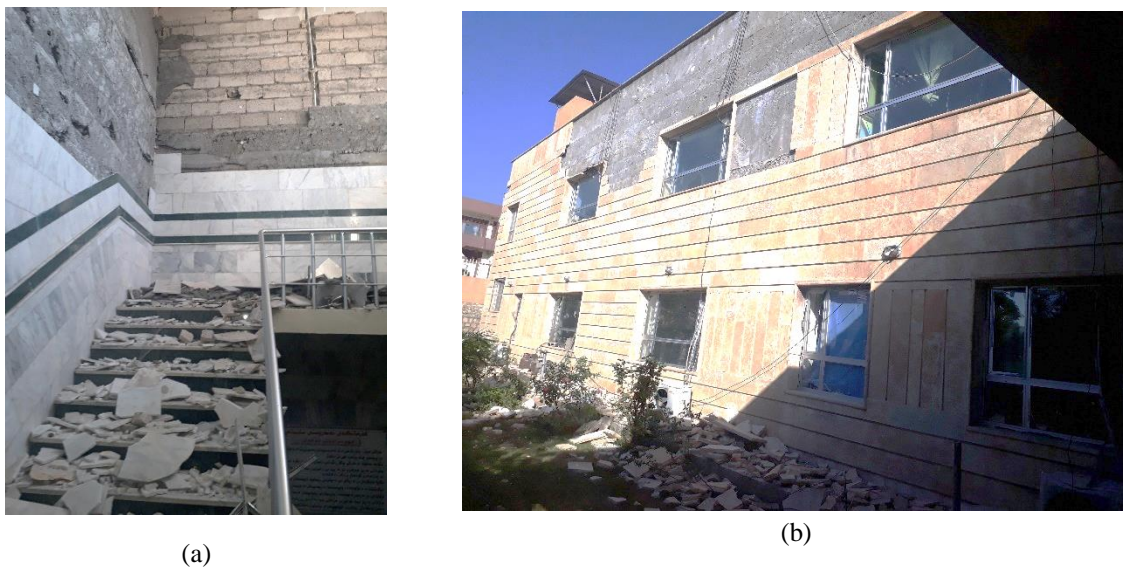
operational immediately after the earthquake. The only cause of this type of falling was not having a strong bond between the material and the wall during the oscillation of the building during the earthquake. This happened as poor material used in constructed them which is very clear in Figures 26 (a) and (b) where the walls did not even crack while all the finishing materials are peeled off. The possible solution is to repair the area using stronger mortar and using a wire mesh as reinforcement.

Fig. (26) Finishing material state in the Darbandikhan general hospital (a) Falling off of the tiles inside (b) Hilan stone falling outside.

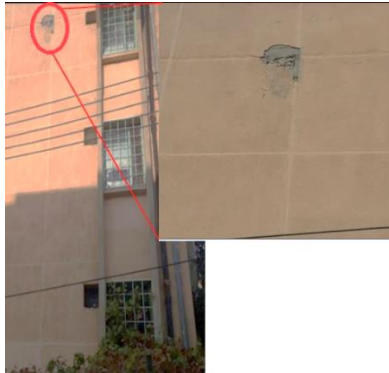
Concrete spalling of the joints in frame buildings was another frequent issue found in some of the R.C buildings in both Darbandikhan and Halabjah. It is frequent when there is an infill wall between the columns and the infill wall is stronger than the concrete of the joint. The philosophy of the design for earthquake recommends having stronger joints than beams and even columns. The main reason for this is the lateral forces are transferred from one floor to the other beneath through the joints and walls as it can be seen in Figure 4 (c). Therefore, the walls have to act like infills not to block the movement of the joints. So, the infills should have cracked not the joints opposite to what it

can be seen in Figures 27 (a) and (b). Another reason is not having enough confinement in the joints as it is clear from Figure 27 (b) where the joint has only one tie extended from the column. The solution is to make the joints stronger than the infill wall. This can be done using the same method of PTMS for strengthening the joints by increasing the confinement.

Fig. (27): Concrete spalling in the joints in frame buildings (a) seven-storey residential building in Halabjah (b) Municipality building of Darbandikhan

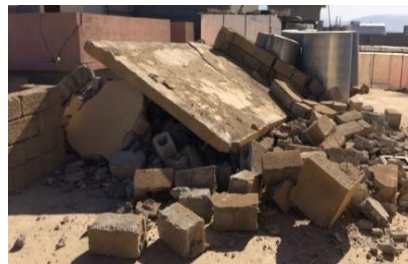
Another frequent damage and sometimes collapse type were found in penthouses which can be seen in Figure 28. The main reason for these failures is that the response acceleration is higher on the top floor and this causes a huge displacement. More, the penthouse has huge slabs and sometimes even a parapet which adds

the mass with having a few walls to stand against the inertia forces causing them to fail or collapse. Not having enough connection between the base of the penthouse and the slab its build

upon is another factor making it vulnerable to lateral forces. It is proven that with having more axial forces on a member the displacement would be restricted.

Fig. (28): Collapse of the penthouse
