REFLECTIONS OF HALABJAH EARTHQUAKE EFFECTS ON THE STRUCTURAL BUILDING DAMAGES IN HALABJAH AND DARBANDIKHAN

WRYA ABDULLAH¹, SERWAN KHORSHEED RAFIQ and YOUNIS M. ALSHKANE
College of Engineering, University of Sulaimani, Kurdistan Region-Iraq

KEYWORDS: Earthquake effects; Lessons learnt; Structural damages; Halabjah Earthquake

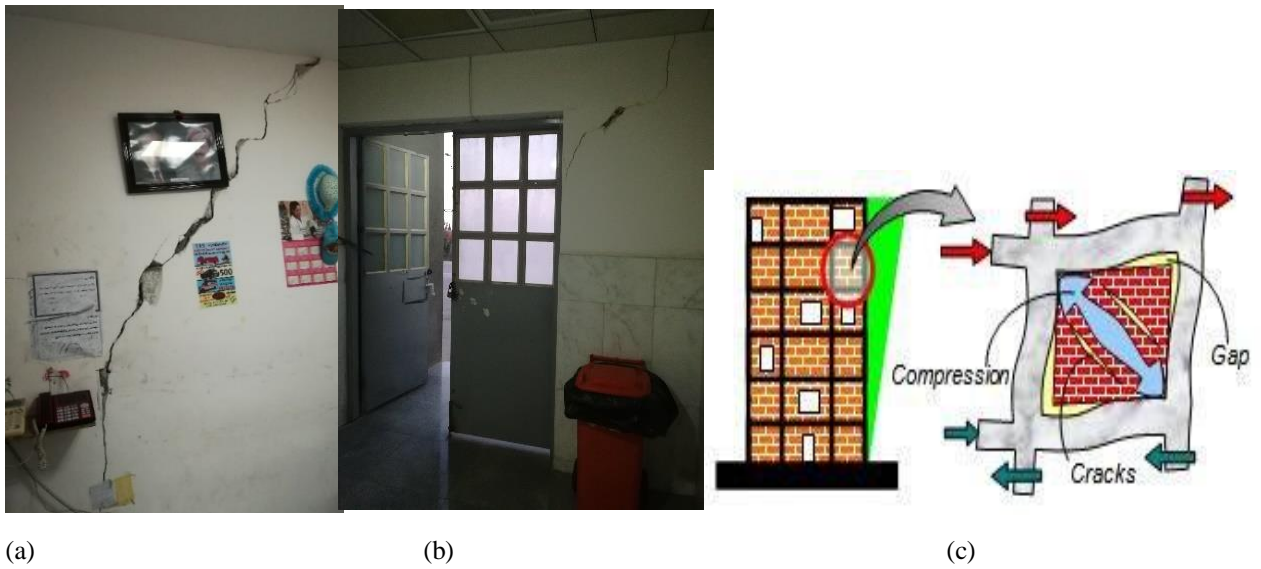
Halabjah is located 14 km away from the Iranian border. It is one of the cities in Kurdistan Region of Iraq which is at $35^{\circ}11'11''$ N $45^{\circ}58'26''$ E. The epicenter of the quake was only 30 km away from Halabjah. During the site investigation visit, no serious damages were observed in buildings in Halabjah, even though, the name of was attributed it based on (USGS, 2017a). The most common types of damage in Halabjah was cracking of infill walls due to the to and fro motion of the buildings during the earthquake. These cracks can be seen in the R.C frame buildings and in partition walls as they transfer the lateral loads from beam-column joints of the upper floor to the one beneath working like a brace that will be exposed to a huge compression force during an earthquake as it can be seen in Figure 4 (c). Also, because those infill walls were made out of concrete blocks, they are weaker than concrete in compression and as a result they develop cracks. These types of cracks are usually diagonal for the reasons mentioned. Examples of the cracks were observed in Halabjah Children Hospital as it can be seen in Figures 4 (a) and (b). The possible solution recommended by ASCE/SEI, (2007) for these walls is repairing of the finishing with blocking the crack using epoxy or strong mortar injection (ASCE/SEI, 2007). The

(a) (b) (c)
Fig. (4): (a) and (b): Cracks in infill walls in Children Hospital in Halabjah (c) Illustration of how infill walls work during an earthquake (Murty, 2004c)

detailed procedure is described by (Dehghani et al., 2015) as it can be done by peeling off the whole cracked finishing surface from both sides and repairing the cracks by filling them with strong mortar then carrying out the finishing on both sides once the mortar dried out. This solution is considered as sufficient, as the main function of infills are to be used as partitions otherwise the whole load is carried by the frame. In fact, they are deliberately built to damage during an earthquake to dissipate some energy based on (Eurocode 8, 2004).

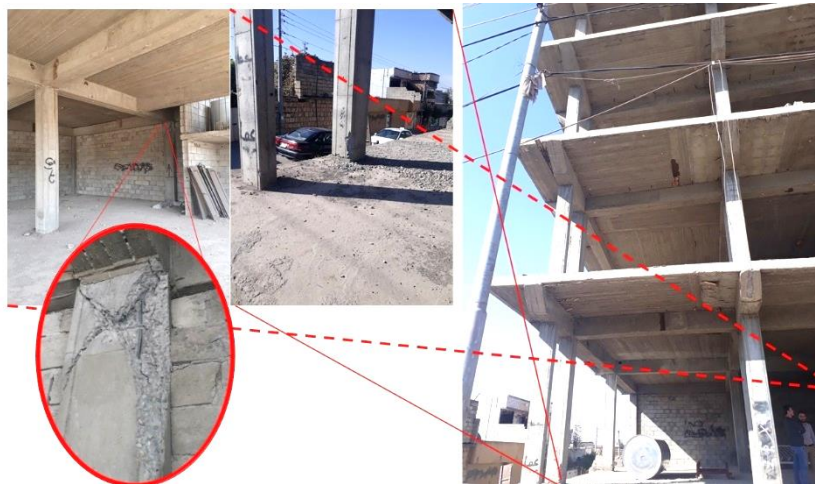
There were some column hinges formed in some of the commercial R.C frame buildings in the area such as that shown in Figure 5 and Figure 6. This type of failure can be explained as the building is not designed to resist earthquake loads and the principle of strong column- weak beam was not followed to prevent collapse. Also, the concrete used for the columns could crumble easily using a little force of a hand so the columns could not resist the shear force on them as the concrete was extremely weak. The authors confirmed that the concrete of the columns could easily come off by using a force as little as a kick as it can be seen in Figure 6. Therefore, due to the oscillation of the building and stiffening the building with masonry walls, the column ends were not free to displace and as a result those hinges were formed. As for retrofitting the columns of this building, some methods are proposed such as using steel caging and PTMS which is post tension metal strap and it is widely proven that it will retrofit the columns easily (Chin et al., 2020; Garcia et al., 2014; Helal, 2012). The method works by tying high tensile strength steel straps around affected areas of the columns using a pneumatic machine for tensioning and then clipping the ends to fix them. Another method is using I section columns next to the existing ones to support them in carrying the gravity loads already on the columns.

Fig. (5): Damage in a column of a 7-story reinforced concrete building in Halabjah

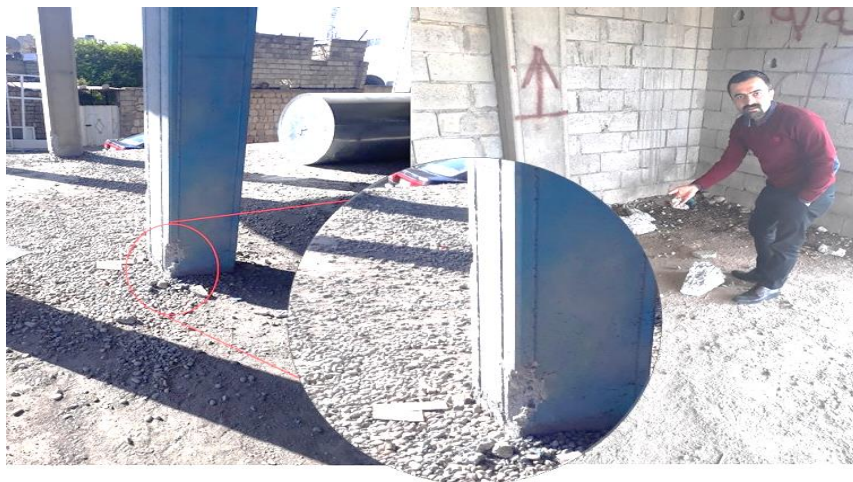
Fig. (6): Easily crushing the concrete by one of the authors as a sign of very weak concrete

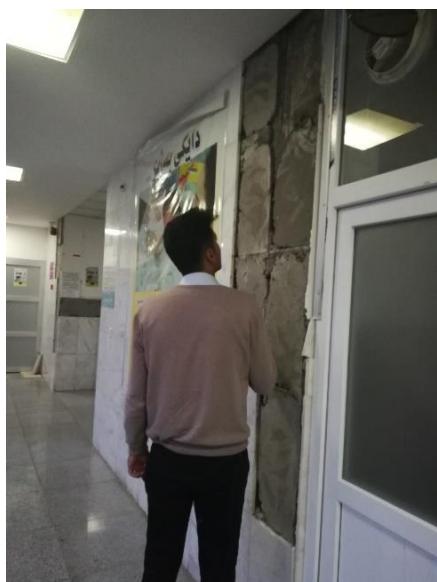
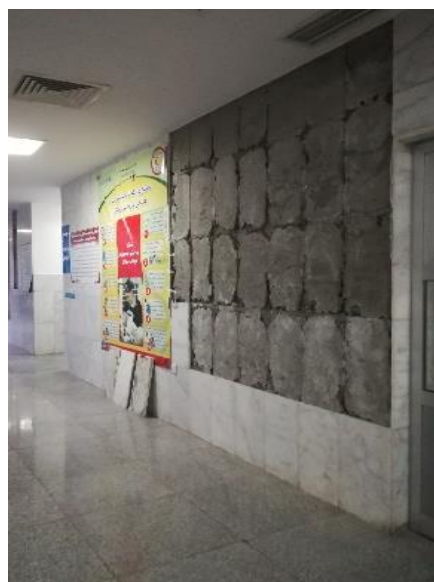
Another common type of damage in both Halabjah was using massive tiles for finishing and Hilan stone for cladding. So, during the earthquake most of the tiles were fallen off because of the vibrations as it is clear in Figure 7 which are the walls of a Hospital in Halabjah. This has led to evacuating the hospital as it caused panic among the staff and patients of the hospital. The irony in this case is that during earthquakes, hospitals must remain fully operational and functional yet they locked down the hospital for hours.

As it can be seen form Figure 7. the status of the concrete block walls was stable as no cracks can be observed in them to point for a failure, therefore, the possible reason for falling the tiling is poor construction and using weak mortar as only the tiles are affected not the walls. Therefore, the solution is to mount new tiles on all the walls again using stronger mortar or change it to gypsum plastering as it is more

Fig. (7): Falling of heavy tile finishing inside the Children Hospital in Halabjah

suitable in terms of construction.

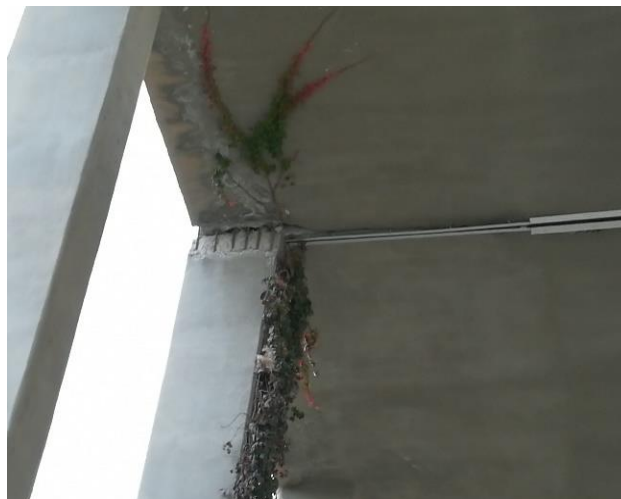
Last type of damage noticed by the authors was in Halabjah Children Hospital and it was the pounding effect happened between the construction joint of the building as it can be seen in Figure 8. This is because the space of the joint was not large enough to house the displacement of the top floor and caused hammering between the two parts of the buildings when they displaced towards each other during the earthquake. The possible solution is to renovate the construction joint and grout the concrete cover of the columns using stronger mortar as the reinforcements were exposed to the air. The columns were in front of the hospital and the load on them was not heavy enough to cause worries but still repairing was needed.

Fig. (8): Pounding effect between two columns in the Children Hospital in Halabjah

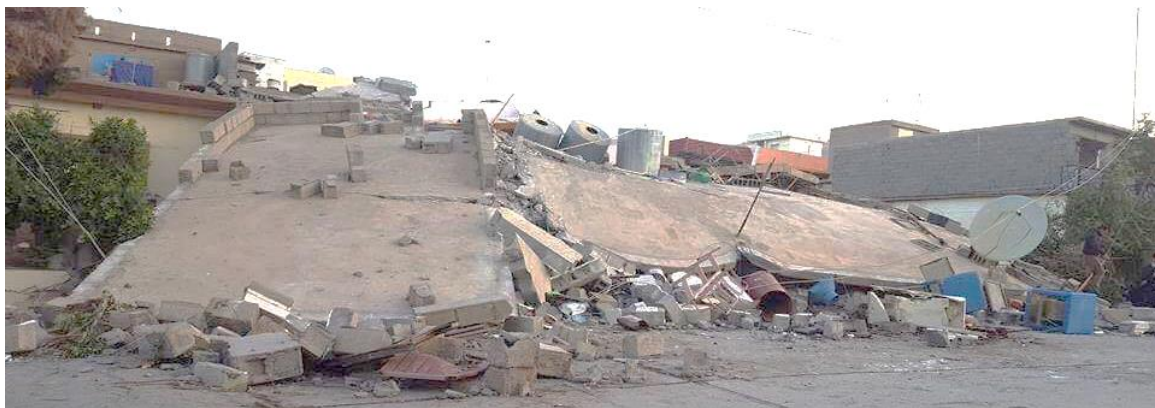
Numerous factors can contribute in collapsing of these buildings. For instance, in the building shown in Figure 9, which was a two-storey building with a frame base and two masonry floors, apart from using two different systems combined, the mass of the slab and very deep lintels over windows and doors were accumulated in front of building as it can be seen in Figures 10 and 11. This caused it to have more inertia forces during the earthquake and because the upper story was masonry so there was not

enough connection between the slab and the supports as to provide the stiffness needed to balance for the inertia forces based on the illustrations in Figure 13. As a consequence, the slab slipped off on the supports and caused the total collapse of the building. Another factor that added to the causes of the total collapse might be the soft storey effects. Because the ground floor was an open area supported only by long columns that was higher than the other floor as it was used as a storage area. Therefore, based on the analogy of the illustrations in Figure 14, it can be concluded that the mass of the first floor of the building was accumulated on top of the ground floor as lumped mass to create an inverted pendulum that caused a huge unbearable drift due to large amount of inertia force that caused the total collapse. Other factors might be irregularities in the plan of the building, as it can be seen from Figure 9, where the left-hand side of the building was longer, which was extending for the whole length of the land of 20 m, wider with a width of nearly 5 and taller, with an estimated height of at least 6 m as it was double spaced used as a parking area as the witnesses reported three buried cars under the rubble of the building, than the right hand side of the building. Because of this, it required a huge slab thickness of an estimate of 25 to 30 cm with very deep lintels with the depth of nearly 80 to

Figure 9. Collapse of a three-story Building using Hybrid system of (R.C Frame- Masonry) (front view)

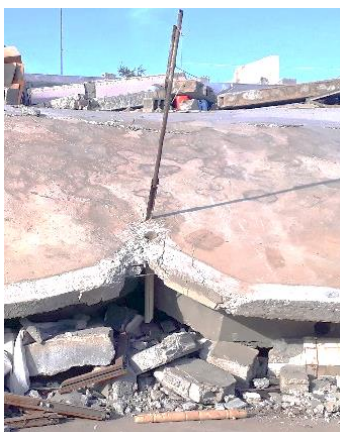
100 cm all over the front of the building. This shifted the center of mass of the whole building towards the left-hand side and front of the building. Therefore, it was less stiff than the right-hand side so it caused a notable rotation of the whole building. Also, three water tanks can be seen in Figure 9 on the roof top which adds the weight to the roof and can cause drift of the roof by increasing the inertia forces. There are other factors which related to the lack of the details of traverse reinforcement of the columns as it can be seen in Figure 12. Also, the quality of the concrete appears to be not satisfactory enough as it did not resist any shear forces of the columns and a clear cut can be observed in Figure 12 which is a sign of not resisting the

Fig. (10): Large R.C lintels of depth of more than one meter in front of the house

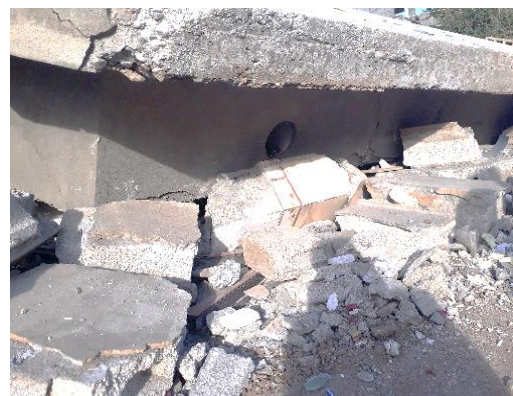
Fig. (11): the scale of the lintel compared to a 40 cm concrete block

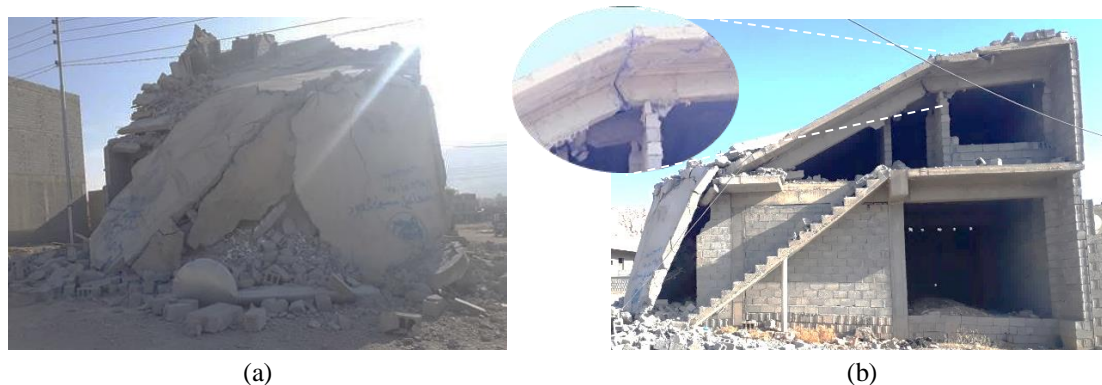
Another building hybrid of a three storey in Darbandikhan, shown in Figure 15, was collapsed due to several reasons apart from using the hybrid system. Most of the above reasons such as strong beam-weak support, asymmetry in plan, and huge slab mass are still true for the failure of this building. Also, Figure 15 (b) shows the side view of the building, and it can be seen that the building was spacious at the first-floor level and there was barely a wall to support all the beam and slab masses. Moreover, it was obvious that the cantilever slab of the first floor in front of the building had a circular long column with an estimated length of 6 m that was used to support the weight of the slab along with those little brittle walls at the end of both sides the of first floor. Because the mass of the building was not distributed evenly as the back

of the building had an irregular extra floor, as it can be seen in Figures 15 (a) and 16 (a), adding the mass of the back and shifting the center of mass of the building towards the back and its left hand-side. All in all, having only a long column in front and a huge mass at the back and using the analogy in shown Figure 17, it has caused a rotation of the building, especially the third floor of it, towards its left-hand side and causing the total collapse. The evidence of rotation is clear at the base of the third floor as it can be seen in Figure 16 (a). The crack patterns on the slab, which can be seen in Figure 15 (a), point to the path of the yield line of the slab as it had left with no other supports apart from the long column during the earthquake which can be seen in Figure 16 (b). This happened as, during the earthquake, the slab of the building with

Fig. (15): (a) Front view of a collapsed three-story hybrid building (b) Side view of the same building

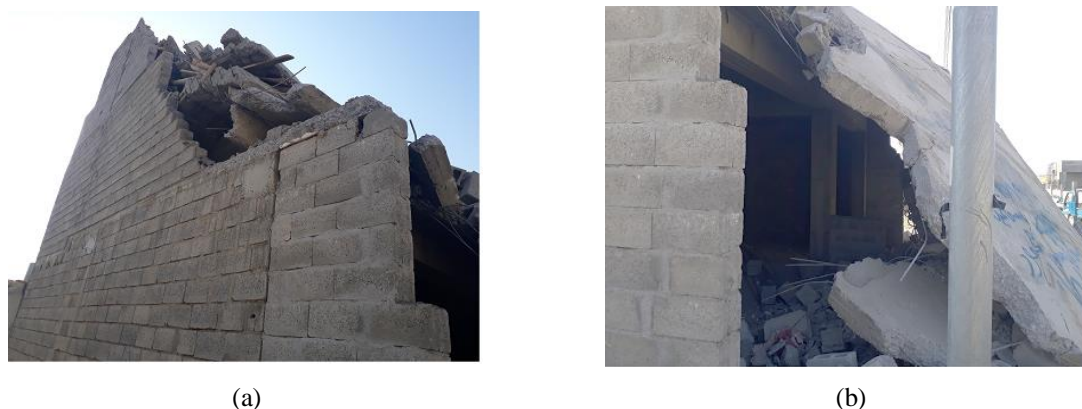
additional mass of the third floor started rotating towards left so the masonry walls, those helped the long column in carrying the weight, failed and scattered into pieces as they are brittle and the amount of the contact area was not much due to the spacious area. Concrete blocks with no cracks can be seen on the ground which points failure due to rotation. The rotation of the slab had left the column alone in carrying the weight of the slab and from the cracks of the slab it can be concluded that the column was strong enough to cause punching shear and cracks in this pattern in the slab, otherwise, the slab would have just collapse without any cracks of this pattern. Furthermore, a factor that aggravated the situation was not knowing the behavior of the

members and not detailing them correctly, for instance, as an obvious shear crack and a shear failure, which is brittle and terminal, can be seen from a short deep beam between what seems like a corridor in the first floor as in Figure 15 (b). From the remainder of the reinforcement of that beam, it can be concluded that it had reinforced as the extension of the other beam and was not treated as a deep beam therefore, it failed in shear breaking the slab into two pieces at that location. A small lintel can be seen behind the shear crack which failed in shear as the left hand-side of it scattered into pieces. These summaries the total causes of failure of this building.

Fig. (16): (a) Rotation of at the base of the third floor (b) A collapsed circular column

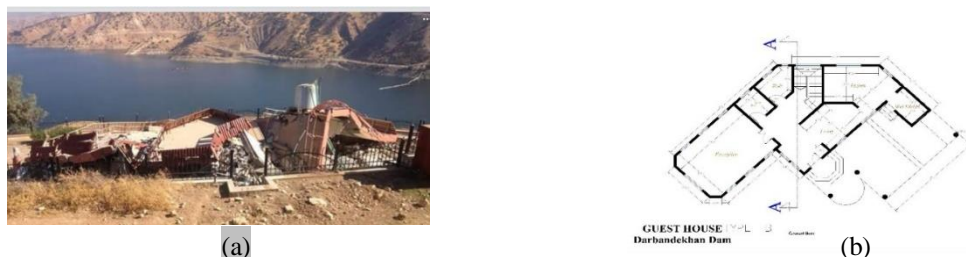
Another collapsed masonry hybrid building was a guest house of the dam shown in Figure 17. From the plan of it, shown in Figure 17 b, it can be concluded that the layout of the plan was not symmetric by using unparallel walls which

provides minimum resistance to lateral loads. Also, the columns in front of the buildings were supporting huge slabs above them without any beams or walls in between to increase their stiffnesses. A beam can be seen hanged on the

slab between two columns without having any columns or girders to transfer its load. This leads to having a huge inertia forces during an earthquake which leads to rotation of the building as it is illustrated in Figure 18 and led it to fail because of the asymmetry in the plan.

This leads to an asymmetry in the stiffness as the first floor of the building was stiffened using masonry walls, however, the ground floor was stiffened using flat slabs supported only by slender columns.

Fig. (17): (a): Collapse of two-story guest house building using (b): Plan of the building

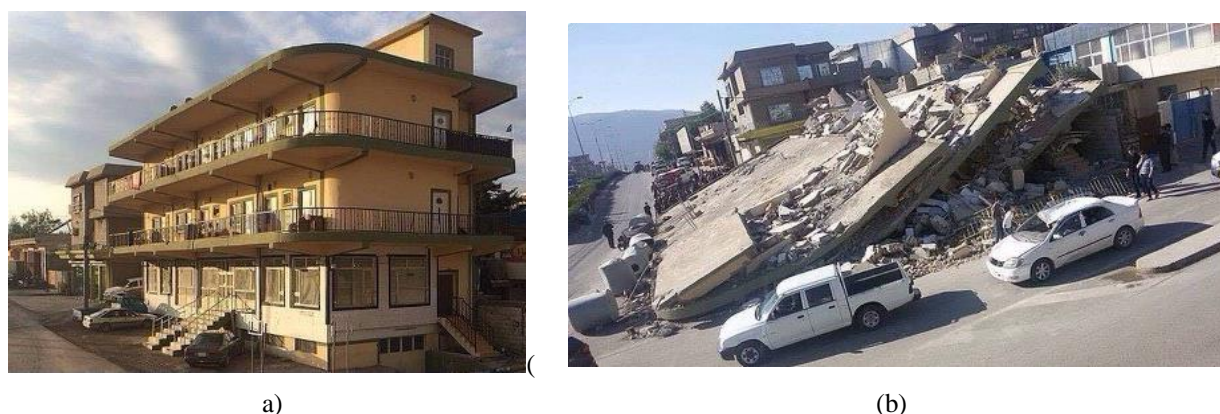
A totally collapsed R.C frame observed is shown in Figure 19. The reason of the collapse was an accumulation of short column effects in the basement and soft story mechanism on top of it at the ground floor. The short column theory suggests that for a building floor with different heights of columns, the shorter columns attract more forces as they will be stiffer and as a result, they will either explode or crack diagonally as illustrated in Figure 20. The building shown in Figure 19 had a basement for which the columns of the left-hand side were shortened to make space for windows. As a result, the left-hand side column backed with the ground and did not have a chance to displace freely as the right-hand side did. As evidence, little spaces left for windows can be seen in the basement which proves that there were long columns buried on the left-hand side. Therefore, if the building jerks suddenly from right to left then the columns on the

right-hand-side would be free to move while the motion of the columns on the left-hand side is restricted by the ground. As a result, the short columns next to the small windows exploded due to attraction of huge lateral forces as they were stiffer leading to a tilt in the building towards left hand-side, exactly where the small windows were in the basement as it can be seen in Figure 19 (b). The evidence of short column effects can be seen as the whole building collapsed towards left-hand side as in Figure 19 (b). The slab of the penthouse and water tanks can be seen on the left-hand side of the building which appears as if they were thrown this way due to the sudden failure caused by the short column effects in the basement as it can be seen in Figure 19 (b). Adding to the factors, soft storey mechanism might have been another mistake in the collapse of this building, as the first and second storey of the building were stiffer than the ground floor of

it. So, using the analogy of Figure 14, it can be argued that it has added a reason to the failure. The area moment of inertia of the building added a reason to the failure as the shape was thinner in the direction of the collapse. The aforementioned factors might have contributed in the collapse of this building as having a heavy mass on each

floor and having that slim shape which produced less stiffness in the direction of the collapse. The short column effects, was a fatal mistake in this building otherwise, the authors confirm the elements were supplied with enough reinforcements

Fig. (19 (a)). The building before collapse. (b) Collapse of Four-story R.C frame Building.

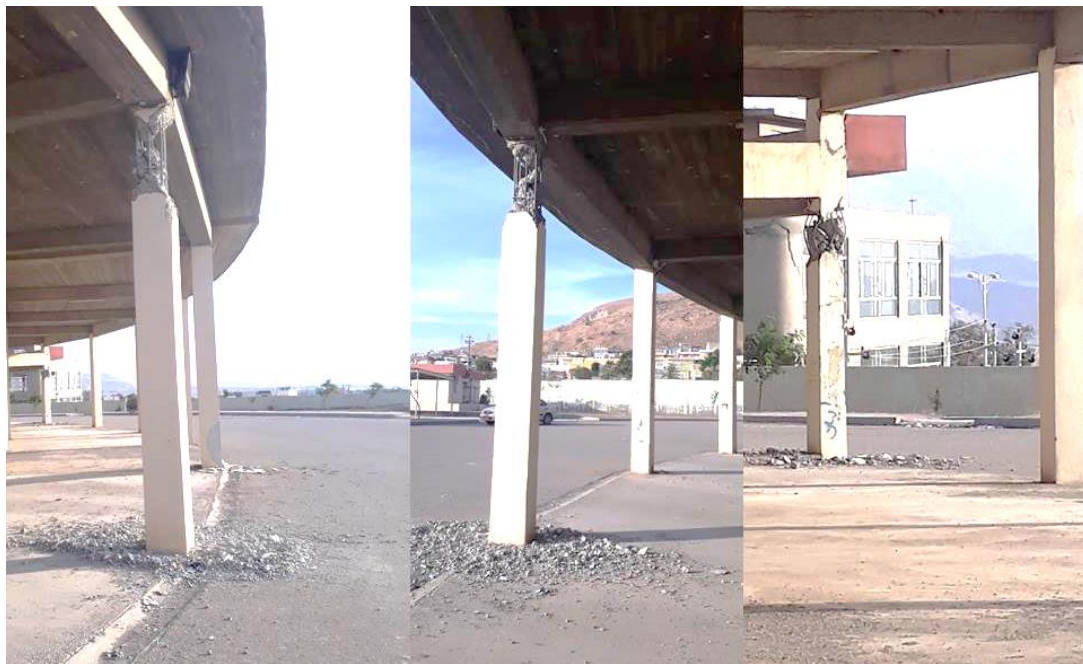
Hinges in upper end columns of Darbandikhan’ main bus and taxi station was described as a “strange failure” by the locals. As it can be seen from Figure 21, only the upper part of some of columns were exploded during the earthquake. Several possible reasons contribute in having this kind of failure in the columns. First is that the upper parts of the columns displace more due to more acceleration response per height while only damping and

stiffness contribute to counteract that much of displacement. However, in this structure, the shape is an oval which provided minimum resistance as it is irregular, and it has no extra stiffness from walls as they were open spaces so the only members resisting the inertia forces were columns. Yet, that irregularity in the plan makes it vulnerable to earthquake as it has fewer number of columns aligned to provide the stiffness needed to counteract the huge inertia

forces produced by the mass of the slabs and beams. It also, causes rotations of the slabs and that was leading to sudden explosion of the top parts. Moreover, the lack of the transverse reinforcement close to beams added reasons for not having enough strength in resisting the lateral forces. It can be seen in Figure 21 that the spacing of the ties in that sensitive area was more than 40 cm which is not allowed under any circumstances. Pounding effects was another reason, as the station was huge enough to be constructed as one part therefore, it was distributed to more than three parts but with different heights which increases the effects of pounding. From figure 22, it is clear that there is a huge vertical crack between the middle columns in the middle of the photograph which is a clear sign of pounding effects. Also, the height of the floor was more than 4 m to accommodate buses and it has heavy beams and slabs on top. This would be fatal as it acts as an inverted pendulum creating a soft story and leading to such explosions. Lastly, poor quality of the concrete was argued to be another factor in hinging those columns, however, because in some of the columns only the cover of them was spalled therefore, it is believed that the lack of

confinement is the main reason not the concrete itself.

Fig. (21): Hinging in columns at exterior supports

The proposed solution was to increase the confinement of the columns. It is recommended to retrofit them using a low cost and fast method of strengthening. First the exploded vicinities have to be filled with a strong concrete where possible otherwise with a strong mortar if it was only the cover spalled. Then, the most suitable method of confinement should be selected in terms price and time of execution. The cheapest and the fastest method in increasing the confinement found in the literature is using PTMS. It is proven by so many researchers in the literature (Chin et al., 2020; Garcia, Hajirasouliha, Guadagnini, Helal, Jemaa, Pilakoutas, Mongabure, Chrysostomou, Kyriakides, Ilki, Budescu, Taranu, Ciupala, et al., 2014; Helal et al., 2016, 2016; Lopez et al., 2012; Ma et al., 2019; Moghaddam et al., 2010). Alternative methods include enlargement of the sections using section enlargement or retrofitting those columns using steel cages. In both cases, the process takes a lot of time and needs extra expenses for the labor works such as reinforcement works, molding and curing.

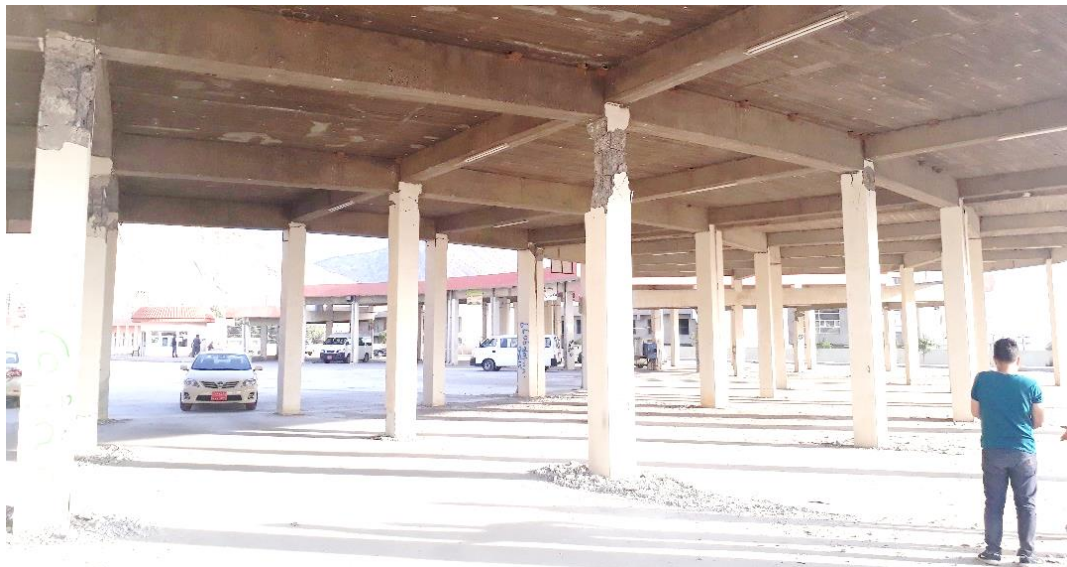
Fig. (22): Hinging in columns with an idea on the shape of the station

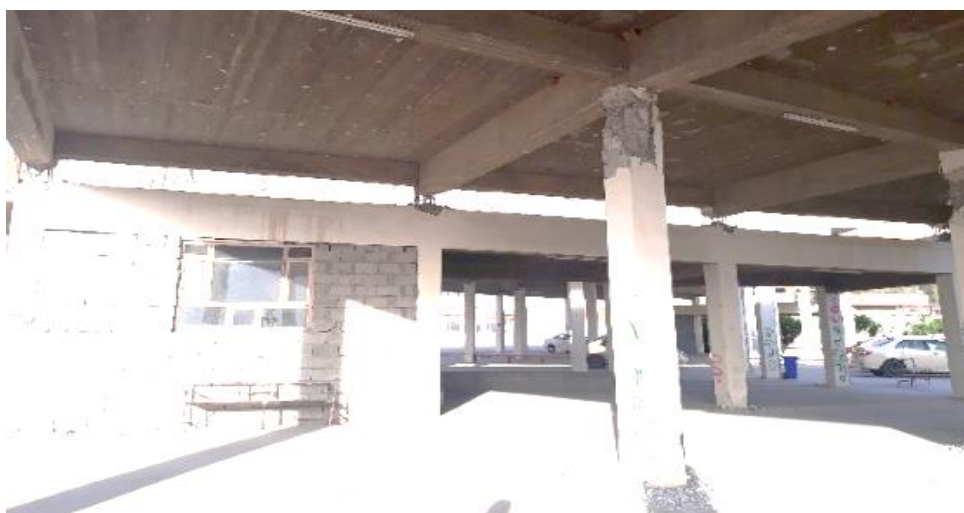
Another problem in that station and the main hospital of the Darbandikhan was having short column effects causing diagonal cracks in some of the columns as it can be seen in Figure 23. Because having a short column is very dangerous as it would explode straight away due to the large forces attracted by their huge stiffness as is illustrated in Figure 20 (Murty, 2004d). The possible solution is to eliminate having those short columns and distribute the

Fig. (23): Short column effects

stiffnesses equally. The solution for those exploded areas of the columns is to fill that gap in between the short columns with strong R.C sections like beams to act like shear walls. Also, to extend the beams on top of them onto the slab of the shorter part of the station to a certain length. Knowing that they still have to be confined with some techniques of confinement such as PTMS.

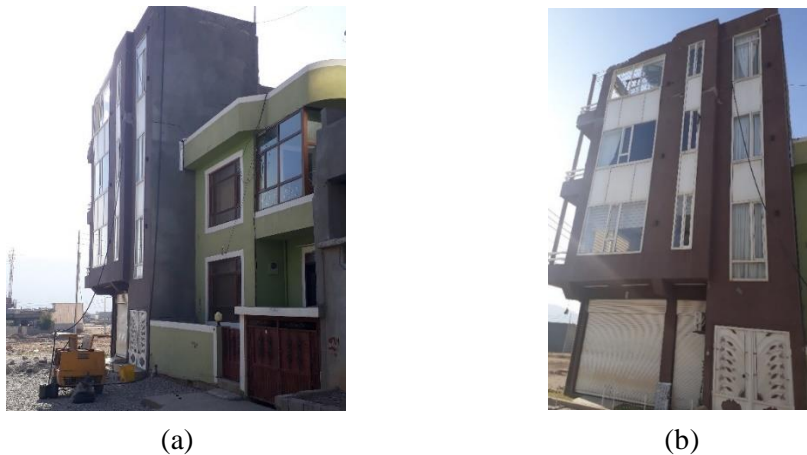
The rotation effects were clearly visible in a residential building shown in Figure 24. The

building was stable at its current state but the twist could have been seen from a distance. The

main reason of rotation is the center of mass of the building was not aligned with the center of rigidity as described by (Murty, 2004b). This can be observed from the back of the building in Figure 24 (a) that one side (left hand-side) is higher which means heavier than the other side. This caused a rotation in the whole three floors

Fig. (24): Rotation of a frame building in Darbandikhan (a) Isometric view of the building showing its back (b) Side view of the building

as it is illustrated in Figure 18. The solution for this case is prevention from the design stage and before constructing it, however, the owner of the building started demolition the last floor to reduce the gap between the center of mass and the center of rigidity.

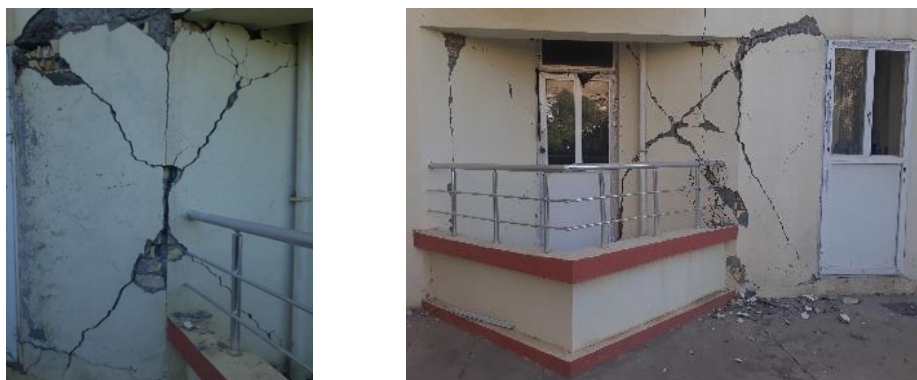
The diagonal cracks in masonry walls were frequent in the general hospital of Darbandikhan as it be seen in Figure 25. The reason for this phenomenon is explained in the previous paragraphs and illustrated in Figure 4 (c). These diagonal cracks along with falling off the finishing tiles and Hilan stone caused panic and fear amongst the staff of the hospital who evacuated the building and caused a lock down of the hospital. Two days after the earthquake and 14th of November the hospital was still closed down while it should have been

Fig. (25): Diagonal cracks in the infill walls

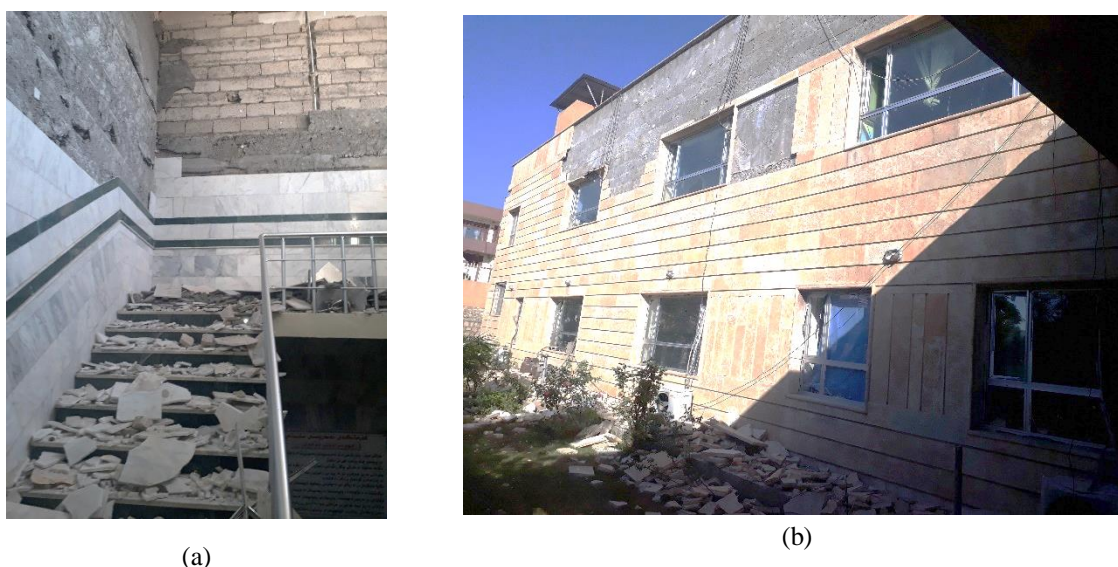
operational immediately after the earthquake. The only cause of this type of falling was not having a strong bond between the material and the wall during the oscillation of the building during the earthquake. This happened as poor material used in constructed them which is very clear in Figures 26 (a) and (b) where the walls did not even crack while all the finishing materials are peeled off. The possible solution is to repair the area using stronger mortar and using a wire mesh as reinforcement.

Fig. (26) Finishing material state in the Darbandikhan general hospital (a) Falling off of the tiles inside (b) Hilan stone falling outside.

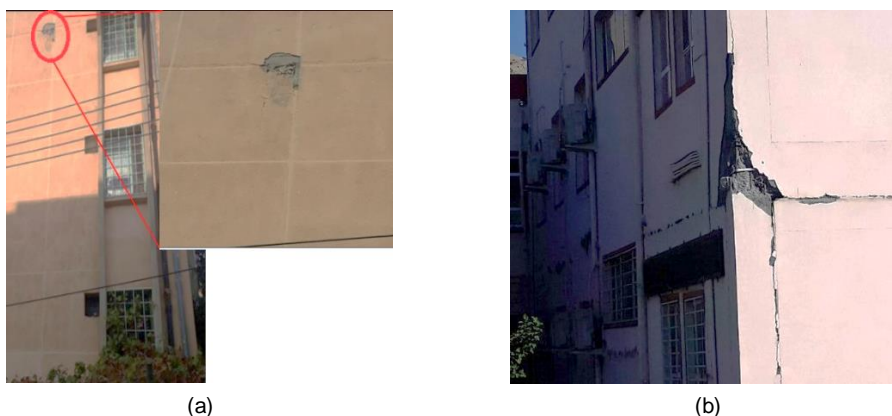
Concrete spalling of the joints in frame buildings was another frequent issue found in some of the R.C buildings in both Darbandikhan and Halabjah. It is frequent when there is an infill wall between the columns and the infill wall is stronger than the concrete of the joint. The philosophy of the design for earthquake recommends having stronger joints than beams and even columns. The main reason for this is the lateral forces are transferred from one floor to the other beneath through the joints and walls as it can be seen in Figure 4 (c). Therefore, the walls have to act like infills not to block the movement of the joints. So, the infills should have cracked not the joints opposite to what it

can be seen in Figures 27 (a) and (b). Another reason is not having enough confinement in the joints as it is clear from Figure 27 (b) where the joint has only one tie extended from the column. The solution is to make the joints stronger than the infill wall. This can be done using the same method of PTMS for strengthening the joints by increasing the confinement.

Fig. (27): Concrete spalling in the joints in frame buildings (a) seven-storey residential building in Halabjah (b) Municipality building of Darbandikhan

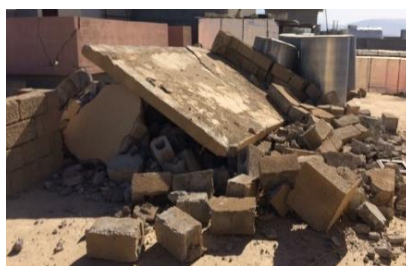
Another frequent damage and sometimes collapse type were found in penthouses which can be seen in Figure 28. The main reason for these failures is that the response acceleration is higher on the top floor and this causes a huge displacement. More, the penthouse has huge slabs and sometimes even a parapet which adds

the mass with having a few walls to stand against the inertia forces causing them to fail or collapse. Not having enough connection between the base of the penthouse and the slab its build

Fig. (28): Collapse of the penthouse
