## PRACTICAL FIELD INVESTIGATION TO INDICATE COMMON FLEXIBLE PAVEMENT DISTRESSES THAT OCCUR IN THE MALIK MAHMOOD RING ROAD-SULAIMANIYAH CITY

This study is about a field investigation to indicate the common flexible pavement distresses that occur in the Sulaimaniyah city. This research is carried out to specify the most frequent types of flexible pavement distresses which happen in one of the main roads in the

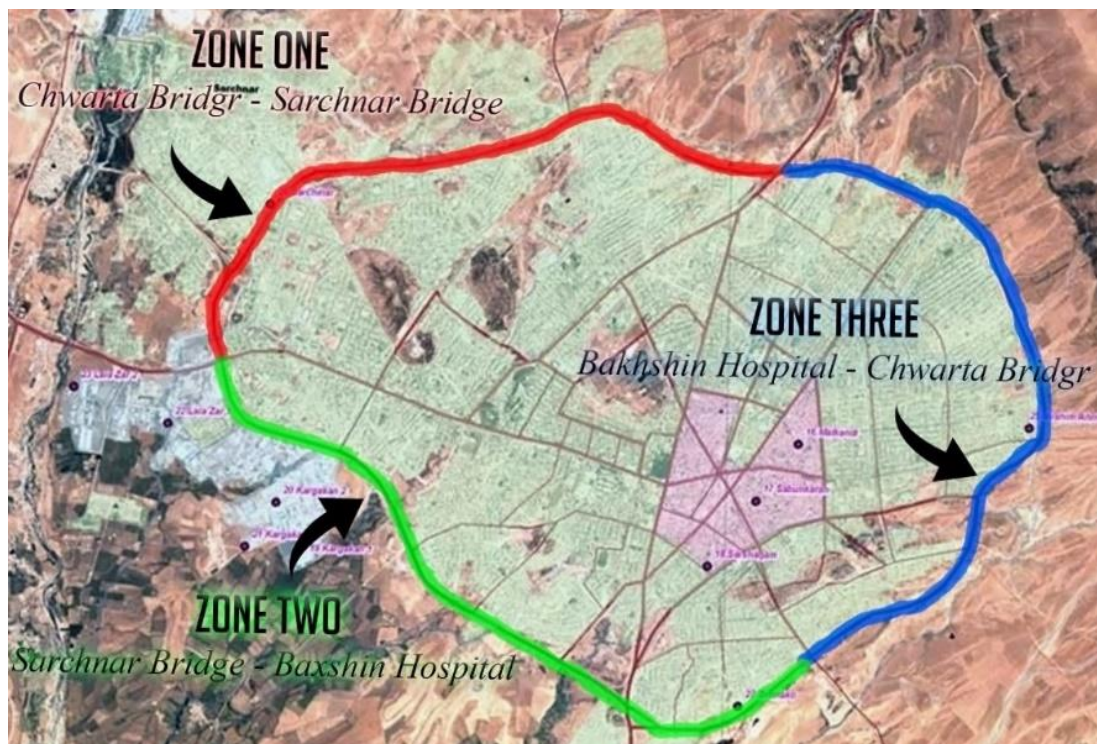
**Fig.(1):** Malik Mahmood Ring Road- Sulaimaniyah City/ Iraq [taken from <https://sleanimuseum.org/Gallery.aspx#gallery-21>]

The road is examined using visual investigation. The whole road is surveyed on foot. Any observation of abnormality of the road is recorded with recording the existence of effective drainage in the affected vicinity. To reassure the quality of the drainage in the affected areas, inspections carried out for that purpose. Additionally, photographs of each distressed area are taken marking their locations accompanied with measuring the level of damage where possible. Firstly, the Malik Mahmood ring road is divided into three zones, as shown in Figure 1, as follows:

Malik Mahmood Ring Road is located in the province of the Sulaimaniyah city in Kurdistan Region of Iraq. The estimated length of the road is 22 km. It is a two-way six lane road with a frontage road on each side. Malik Mahmood road is a service ring road in the Sulaimaniyah city, which has a variety of functions such as serving the industrial and commercial areas along its coverage area. Also, it serves the educational institutions and large residential communities by connecting them together

- 1. ZONE ONE:** Chwarta Bridge to Sarchnar Bridge
- 2. ZONE TWO:** Sarchnar Bridge Bakhshin Hospital
- 3. ZONE TTREE** Bakhshin Hospital to Chwarta Bridge

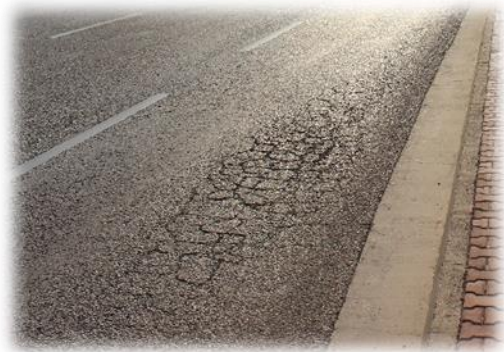
**Fig. (2):** Fatigue Cracking

a) **Fatigue Cracking:** Figure 2 shows an example of a fatigue cracking on the existing road. It looks like the back of a crocodile or an alligator that is why it is called an alligator cracking where a series of interconnected cracks

The presence of fatigue cracking and their severities are presented in Table 2. Results show that there are a lot of fatigue cracking with a variety of severities levels on the Malik Mahmood ring road. The possible causes of these cracks were mentioned in the literature can be the excessive amount of axle loadings, aging of the road, weak surface or base or sub grade and poor drainages. The suggested maintenance methods for repairing this defect is based on the

together. It starts with small cracks in early stages and then develops into many-sided wider cracks with an area of less than 1 m<sup>2</sup>. Table 2. Shows the distribution of this type of cracking with noting that L=Low, M=medium and H=high]

severity levels. For instance, for low severity levels suitable amount of sealant can be used to prevent water entering in to the road layers and for moderate and high severity levels full depth patch is effective.

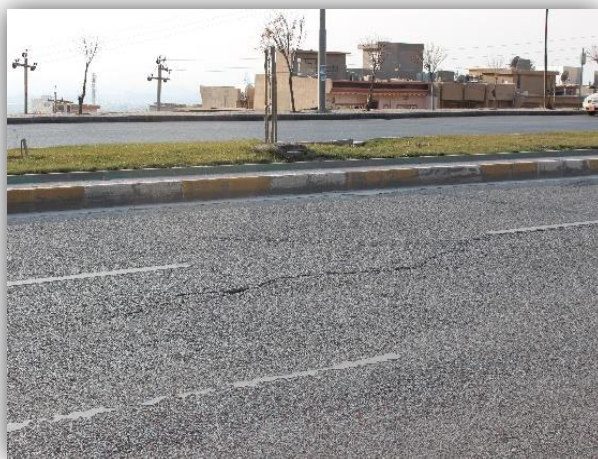
**Fig. (3)** Longitudinal Cracking

b) **Longitudinal Cracking:** Figure 3 shows an example of longitudinal cracking on the selected road. It is a crack that is usually parallel to centerline pavement regardless of the thickness of the crack.

The availability of longitudinal cracking and their severities are showed in Table 3. It indicates that there are a wide range of

longitudinal cracking with a variety of severity levels on the Malik Mahmood ring road. The possible cause of these cracks were explained in

detail in the literatures and in the distress identification manuals, and it is attributed to poor construction paving joint which are usually least dense area. Another factor contributing to this kind of crack is change of the temperature which leads to the shrinkage of the asphalt layer. Otherwise, the reason might be interpreted as the paver might have not worked properly causing the longitudinal segregation of the asphalt. The suggested maintenance methods for repairing this type of distress is upon the severity levels, the existing pavement have low to high severity

levels. It can be performed in the following stages. First, the existed cracks have to be sealed or filled with a mixture of light grade asphalt and fine sand or with emulsion slurry. After that proper drainage has to be assured to avoid future failures in that areas.

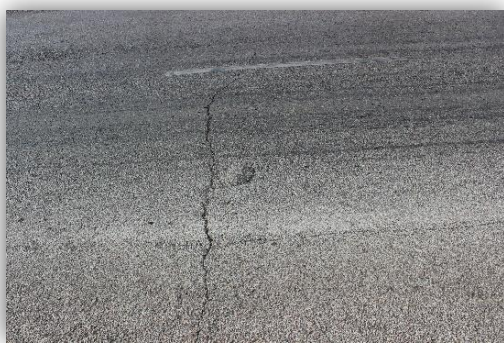
**Fig. (4):** Transverse Cracking

c) **Transverse Cracking:** Figure 4 shows a typical transverse cracking on the road. It is a crack which its direction is usually perpendicular to the direction of the longitudinal crack or the pavement centerline

The transverse cracking and their severity levels of the Malik Mahmood ring road are showed in Table 4. It can be clearly seen that there are a lot of transverse cracking with presence of severity levels from low to high. The possible causes and the suggested maintenance methods of these cracks are the same as longitudinal cracking with a little difference.

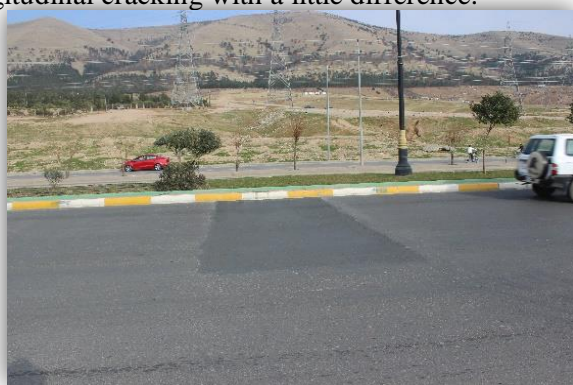
**Fig. (5):** Patching

d) **Patching:** Figure 5 shows the patching on the existing road. Patching takes place after repairing performed on the road where the original surface is replaced with added materials to the surface. The usual size of it, is more than 0.1m<sup>2</sup>.

The presence of patching and their severity levels are presented in Table 5. Results indicate that there are a wide range of patching with a

variety of severities on the Malik Mahmood ring road. They usually cause a rough pavement that leads to cracks in the joints. The possible causes

of these cracks are due to combination of several types of previous cracks that had been treated or replaced with new pavement and may lead to patching distresses. Those treatments include the treatment of potholes, removal of fatigue cracking, shoving and corrugation patching. The suggested maintenance methods for repairing this defect is as treatment with removal or placement of new overlay as patches are repair actions in themselves.

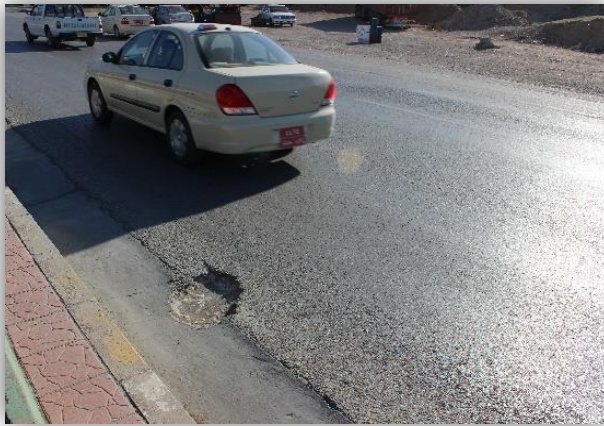
**Fig. (6):** Potholes

The possible causes of these defects are generated where the severe alligator cracking that is not treated. The alligator cracks leave small and weak chunks of pavements on top of the surface of the pavement which are vulnerable to repeated loads as they will be dislocated to new places and a hole will be created. The other possible reasons of pothole might be having weak points in either the base course or subgrade layer. The most effective method that is

e) **Potholes:** Pothole, as shown in Figure 6, is a hole in a road surface that is created naturally to penetrate to the base course of the pavement from hot mix asphalt layer. The frequency of potholes and levels of severity are presented in Table 6. It can be seen that there are a lot of potholes with a variety of severities on the selected area. This type of distress causes the pavement to allow moisture to infiltrate the layers and causes roughness which can cause serious damage to vehicles going at high speed.

suggested as a maintenance for repairing this type of distress is to remove dislodged chunks and then patch it.

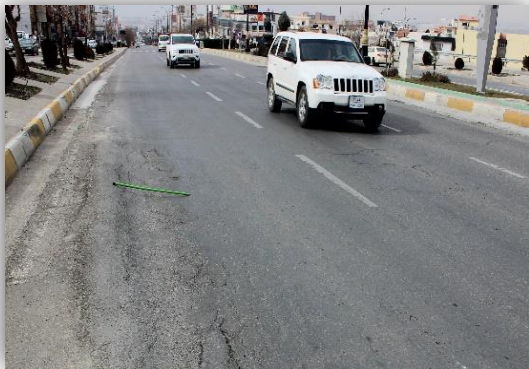
**Fig. (7):** Rutting

f) **Rutting:** Rutting (shown in Figure 7) is a form of distress, which is a permanent surface deformation along the path of the wheel. The availability of rutting and their severities are presented in Table 7. This type of distress tend to pull vehicles into the rut path which inflicts vehicle damage.

The possible causes of rutting include heavy truck loading during high-temperature climates, lateral movement of materials or consolidation and problems in mix design such having inadequate quantity of pointed aggregate and unnecessary asphalt content or mineral filler all of them were proved in past . The most effective method that is suggested as a maintenance method for repairing this type of distress is based on the severity levels of the rutting, if the depth of the rutting is too small it can be left untreated otherwise deep ruts should be removed and replaced by new layer of pavement.

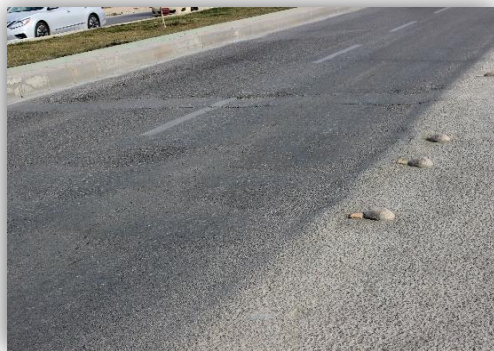
**Fig. (8):** Corrugation and shoving

The possible causes of corrugation and shoving include heavy truck loading on the road where excessive moisture presents in the structure of the pavement and a combination of poor mix design with unstable hot-mix asphalt layer. The effective maintenance method for repairing this type of distress affecting a small area is removing the distorted pavement and patch but if the area is large enough, it indicates the general HMA failure that needing the total removal of the area and overlay.

g) **Corrugation and shoving:** Figure 8, shows corrugation and shoving on the Malik Mahmood ring road. Shoving happen when the surface of the pavement displaces longitudinally over a localized area. The presence of shoving and their severities are presented in Table 8. The recorded data show that there are a lot of shoving with a variety of severities on the selected road, these corrugation and shoving create a rough pavement surface which is uncomfortable for vehicles.

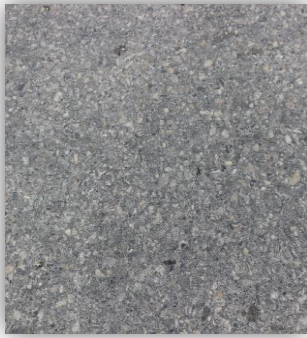
**Fig. (9):** Raveling

h) **Raveling and Polished aggregate:** Figure 9 and 10 show both the raveling and polished aggregate of the Malik Mahmood ring road. Raveling is loss of the main constituent material of the mix which is aggregate that can be fine or sometimes course. However, polished aggregate happens when the binder of the surface is worn away and only the course and some of the fine aggregates left exposed.

The presence of raveling and polished aggregate with their severities are presented in Table 9. The recorded data show that there are a wide range of raveling and polished aggregate on the selected pavement. These raveling and polished aggregate collects water and will cause the loss of resistance to skid.

The possible causes of these types of distresses are heavy and repeated traffic volume, inadequate compaction during construction that leads to debonding between aggregate particles and the asphalt, and water ingestion. The effective maintenance method for repairing this type of distress is applying a skid resistant slurry seal after removing the defected area and patching or overlaying.
